## **RESULTS FROM TWO SIDED QUASI-STATIC (M216) AND REPEATABLE DYNAMIC ROLLOVER TESTS (JRS) RELATIVE TO FMVSS 216 TESTS**

Xprts, LLC  
United States  
Paper Number 07-0361

## **ABSTRACT**

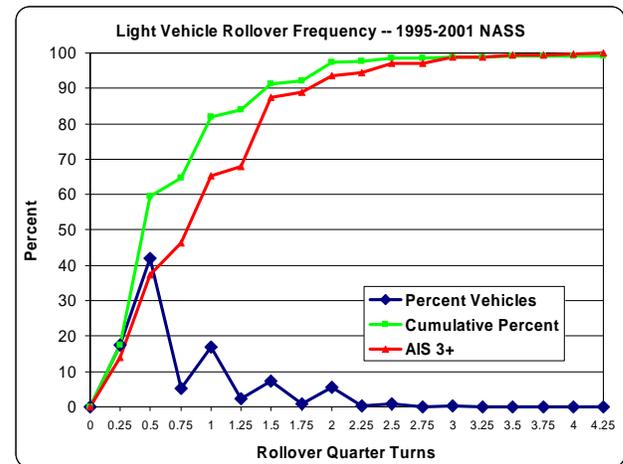
Figure 4. Rollover Frequency and Fatalities.

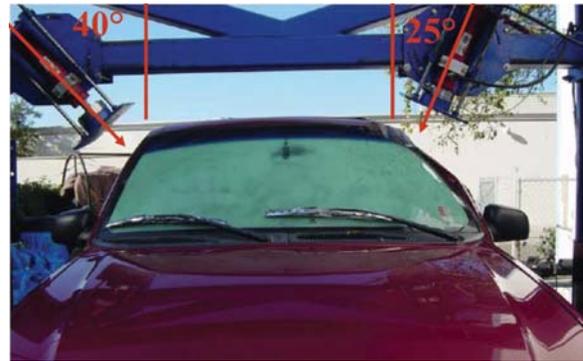
Figure 5. Vehicle in M216 test fixture.

The M216 test presses a 30.5 cm wide 61 cm long platen into the corner of the roof over the A-pillar at 10° pitch and 25° roll. It is pressed to a depth of 12.7 cm while measuring roof resistance. Then a similar platen is pressed into the opposite corner of the roof over the A-pillar at 10° pitch and 40° roll to a depth of 12.7 cm.

and then on the JRS. Photos of the M216 and JRS fixtures are shown in Figures 5 and 6.

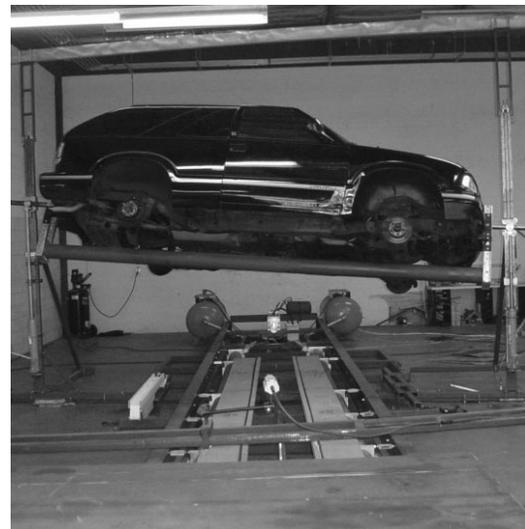
Figure 6. Vehicle in JRS fixture.

The vehicle to be tested (either the complete vehicle or just the occupant compartment with weighting to emulate a complete vehicle) is balanced around its longitudinal roll axis with the approximately correct roll moment of inertia. It is suspended from drop towers at a fixed pitch and yaw above tracks supporting a mobile roadbed segment that can move under the vehicle as shown in Figure 6.

When the test is initiated, the vehicle is rotated at a fixed speed, freely falling a fixed distance to contact the near side of the roof at a given roll angle on the roadbed moving at a fixed speed under it. The vehicle continues to roll, moving freely as the roadbed moves beneath it so that the far side of the roof strikes the roadbed. After the far side impact, the roadbed moves beyond and the vehicle is caught by the drop towers so that it suffers no further damage.[10] The roadbed is instrumented to record vertical and lateral impact loads. String potentiometers record resultant roof displacement and speed during roof impacts at several roof locations inside the vehicle. A number of high speed and real time cameras record the impact.

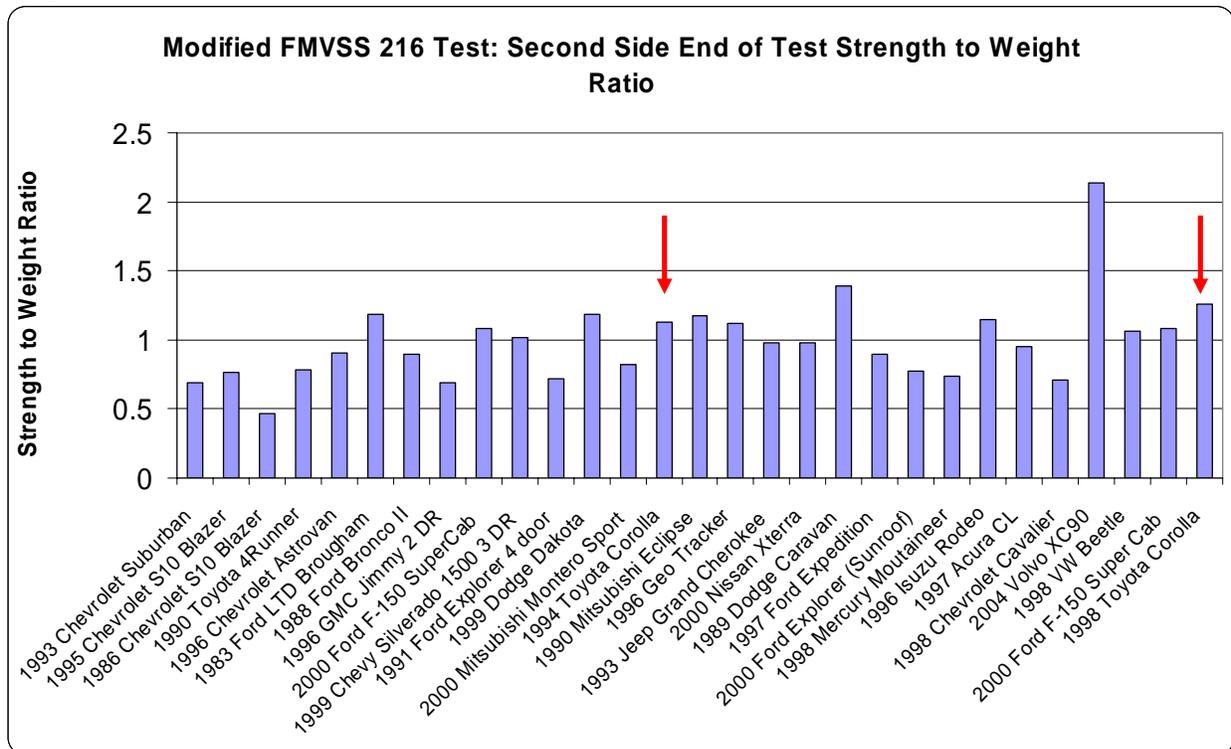
Figure 7. Second side M216 Strength to weight ratio highlighting 2 generations of Toyota Corollas

Two generations of Toyota Corolla roof structures (1994 to 1997 and 1998 to 2002) were carefully inspected and compared. The FMVSS 216 and M216 test results are shown in Table 2.

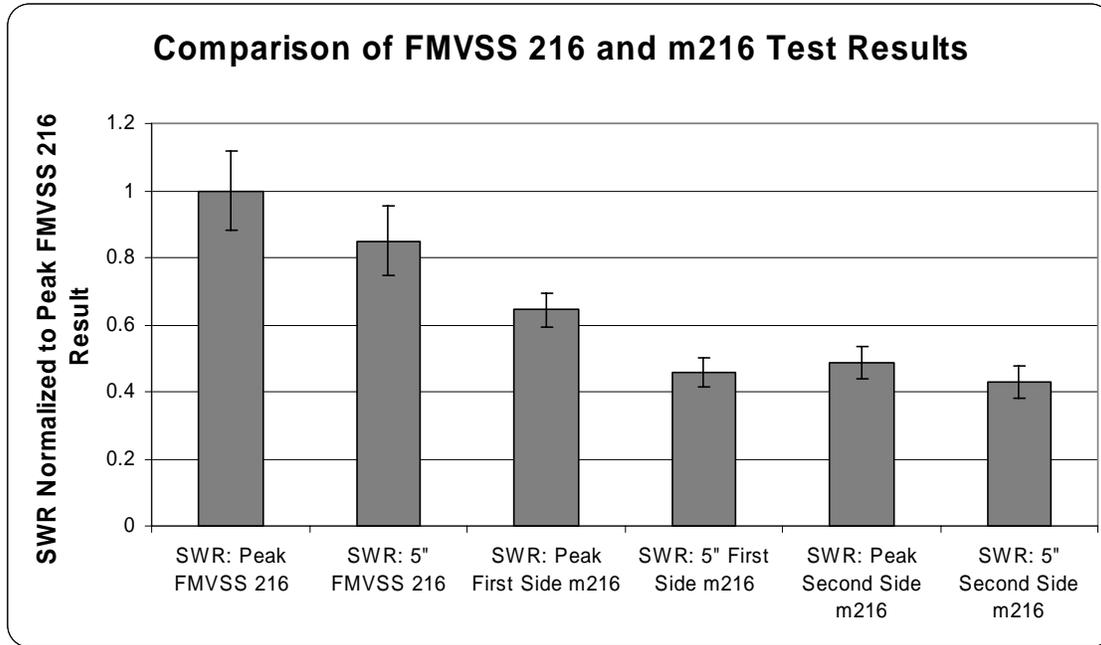
in Figure 8. The far side strength of the roof is about half of that indicated in the FMVSS 216 test and therefore often only comparable to the weight of the vehicle. This results from the increased pitch angle of the loading platen (which exerts force primarily on the A-pillar) and the fracturing of the windshield which acts as a shear web between A-pillars and header.

**Figure 8. Comparison of FMVSS 216 and M216 tests at peak and 5” of displacement.**

The generic effect of these measurements in comparison to FMVSS 216 measurements are shown

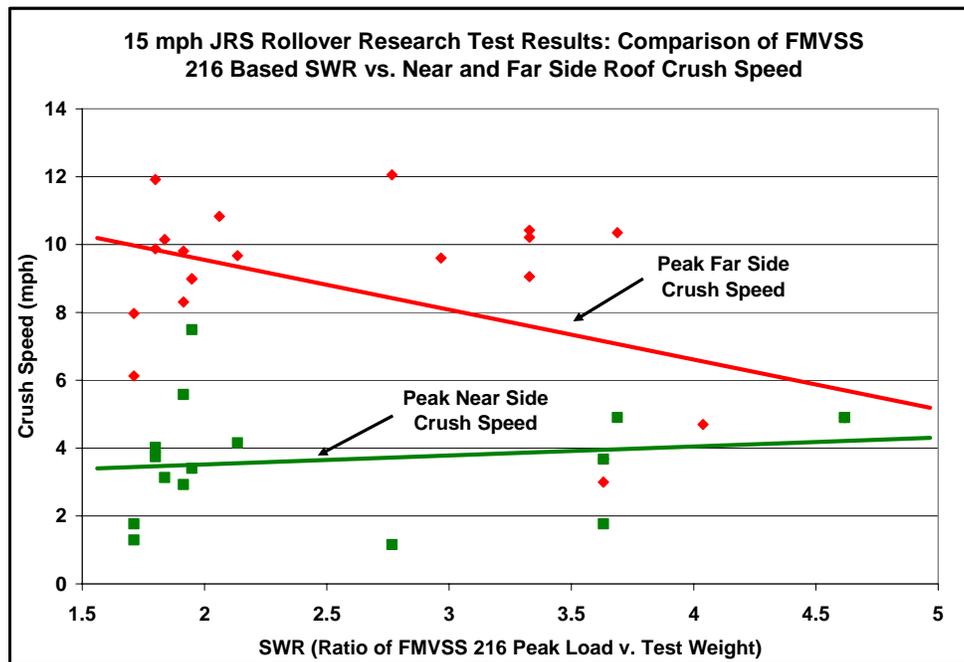
Figure 9. Peak roof crush speed of near and far side measurements vs. SWR at test weight.

As expected, the stronger the roof, as measured by the current FMVSS 216 test, the lower the far side roof crush speed as measured at the middle of the roof rail. For the near side as measured at the A-pillar the average crush speed is low and constant with SWR.

Although there were some differences in the test protocol for each of the seventeen vehicle tests, a comparison can be made between peak roof crush speed and roof strength for the same point on each vehicle. Figure 9 and 10 illustrates these analyses respectively.

There is some correlation between the SWR in FMVSS 216 testing and the results of JRS testing. Since the FMVSS 216 test does not initiate the buckles and collapse that are common in actual rollovers (and in JRS tests) it does not give results that correspond to the actual behavior of a roof in a rollover. However, if the roof were required to be strong enough to preclude buckling the correlation would be good.

The roof crush speed and roof crush indicated in Figure 9 and 10 is as measured in each impact and is not cumulative. From these tests it becomes very clear, that different roof structure designs have grossly different cumulative and residual crush characteristics, which are unknowable and misrepresented by post crash investigators without such JRS one roll at a time dynamic measurements.

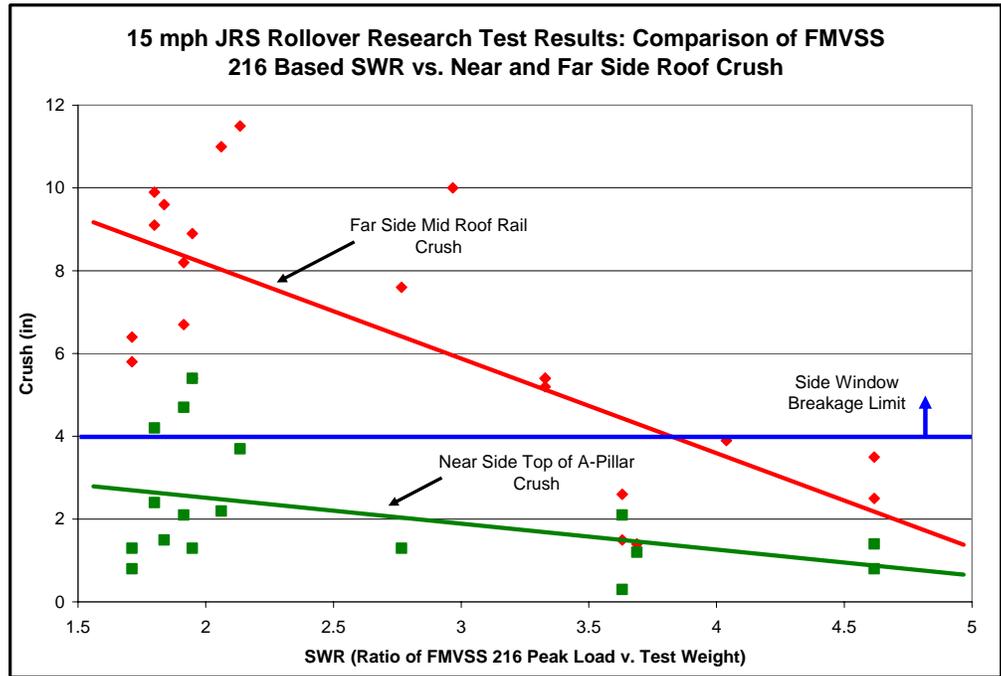
Figure 10. Comparison of Vehicle SWR and Far and Near Side Crush.

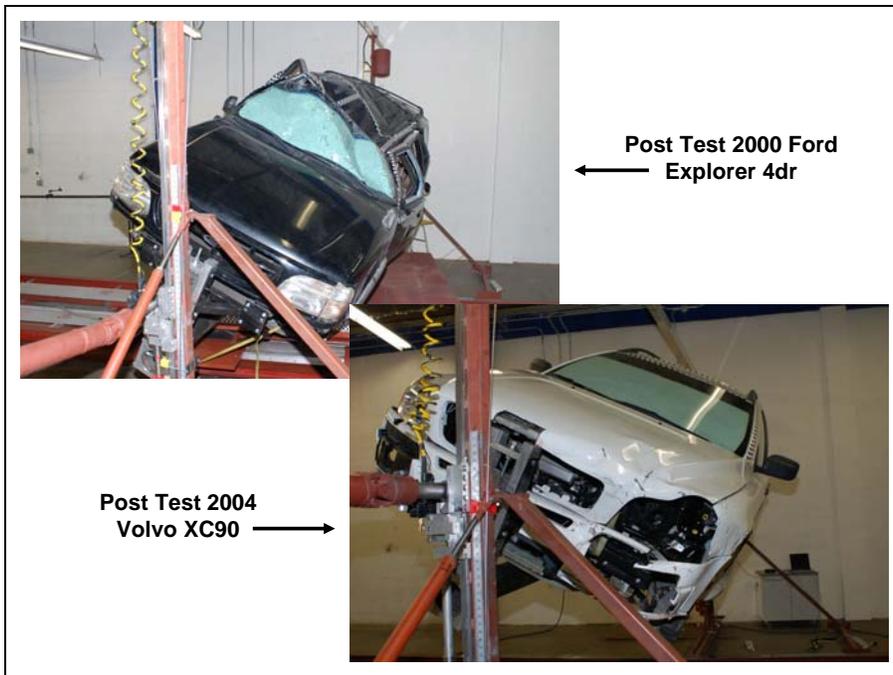
A comparison of the crush and crush speed between the two Ford production vehicles shows a dramatic difference between the rollover designed XC90 and the Explorer roof structures. In the XC90 there was a dramatic decrease in both of these crucial metrics; 82% in crush and 50% in crush speed. Figure 12 illustrates the reduction in crush speed and crush that is possible with a rollover designed vehicle (the XC90) as compared to a typical production roof vehicle (the Explorer).

Figure 11. Post-Test Photographs of the Explorer and XC90.

The Explorer and the XC90 vehicles after two rolls are shown in Figure 11.
