Flaws in Malibu I and II interpretation of test results that have influenced many poor rollover roof designs

E C Chirwa, M Mao, T Chen, J Latchford

Bolton Automotive & Aerospace Research Group, Department of Engineering & safety, The University of Bolton,
Deane Road, Bolton BL3 5AB, UK

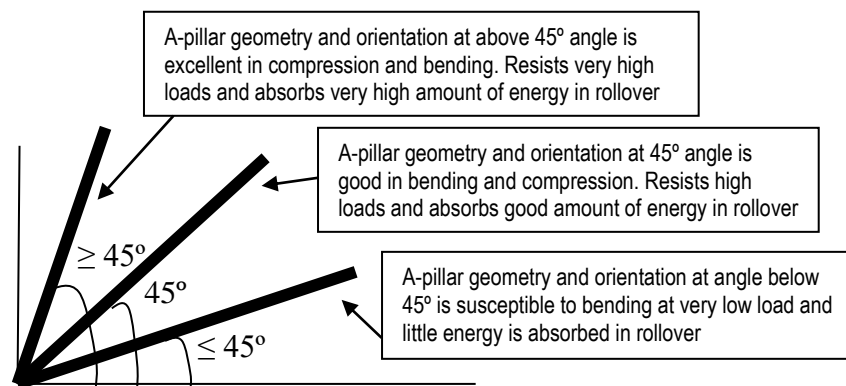
- For the upper A-pillar to perform adequately in rollover crashes, the angle of incidence, that is the angle the upper A-pillar makes with the vehicle global longitudinal axis should be between 90° and 45° as shown in Figure 2. Otherwise if the angle of incidence is too low as seen in many streamlined vehicle body shells that are designed to offer low aerodynamic coefficient, the upper A-pillars become susceptible to early bending with very little energy absorbed. Old vehicles (built between 1930-1960) that had upper A-pillars between 90° and 45° are seen to be stronger than modern aerodynamically shaped vehicles for this simple reason that they resist bending better and delay the rate of rotation of plastic hinge failure. In SUVs, which are still designed within this angle bracket, the pillars are mainly weakened by excessive cut-outs as it will be shown later.

Figure 2. Upper A-pillar design geometry and orientation

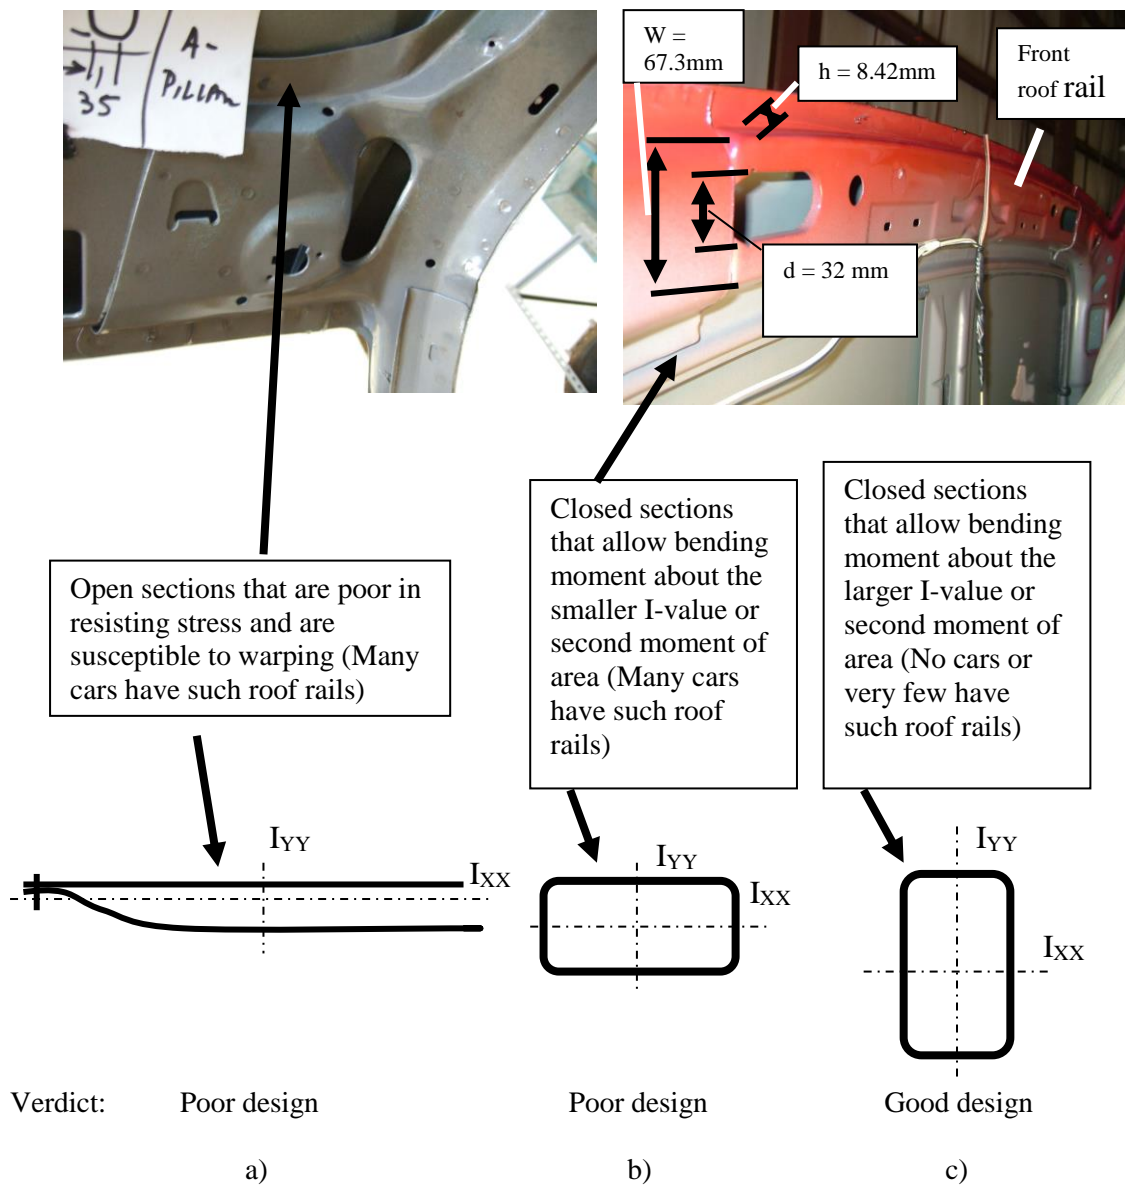
Analysing Figures 3a, 3b and 3c it can be seen that roof rails are still constructed poorly with no aim of creating efficient load bearing components. It will help a lot if the cross-section in figure 3c could

be used in modern cars as the intrusion of the roof rails could be delayed, minimised and hence the overall roof-system intrusion rate could be smaller.

Figure 3. Roof rail design under bending loads

Images in Figure 3 to Figure 9 show that engineers have not utilised the basic fundamental principles of mechanics when designing load bearing structures with holes and cut-outs. Therefore, assessing Figure 9 for instance, it can be said that the front roof rail in a car is a load carrying member that should transfer load from the point of application on the right side of the vehicle structure to the left side and vice versa. The roof itself as mentioned earlier carries very little directional load, but plays a part in transferring shear loads in its own plane. Therefore, in this case roof rails (front, side and rear) require to be properly designed (Figure 3) so that under rollover the load from say the joint at the top of A-pillar front roof rail and side roof rail could be able to be transferred quickly from that joint to the rest of the structure through defined load paths (Figure 9).

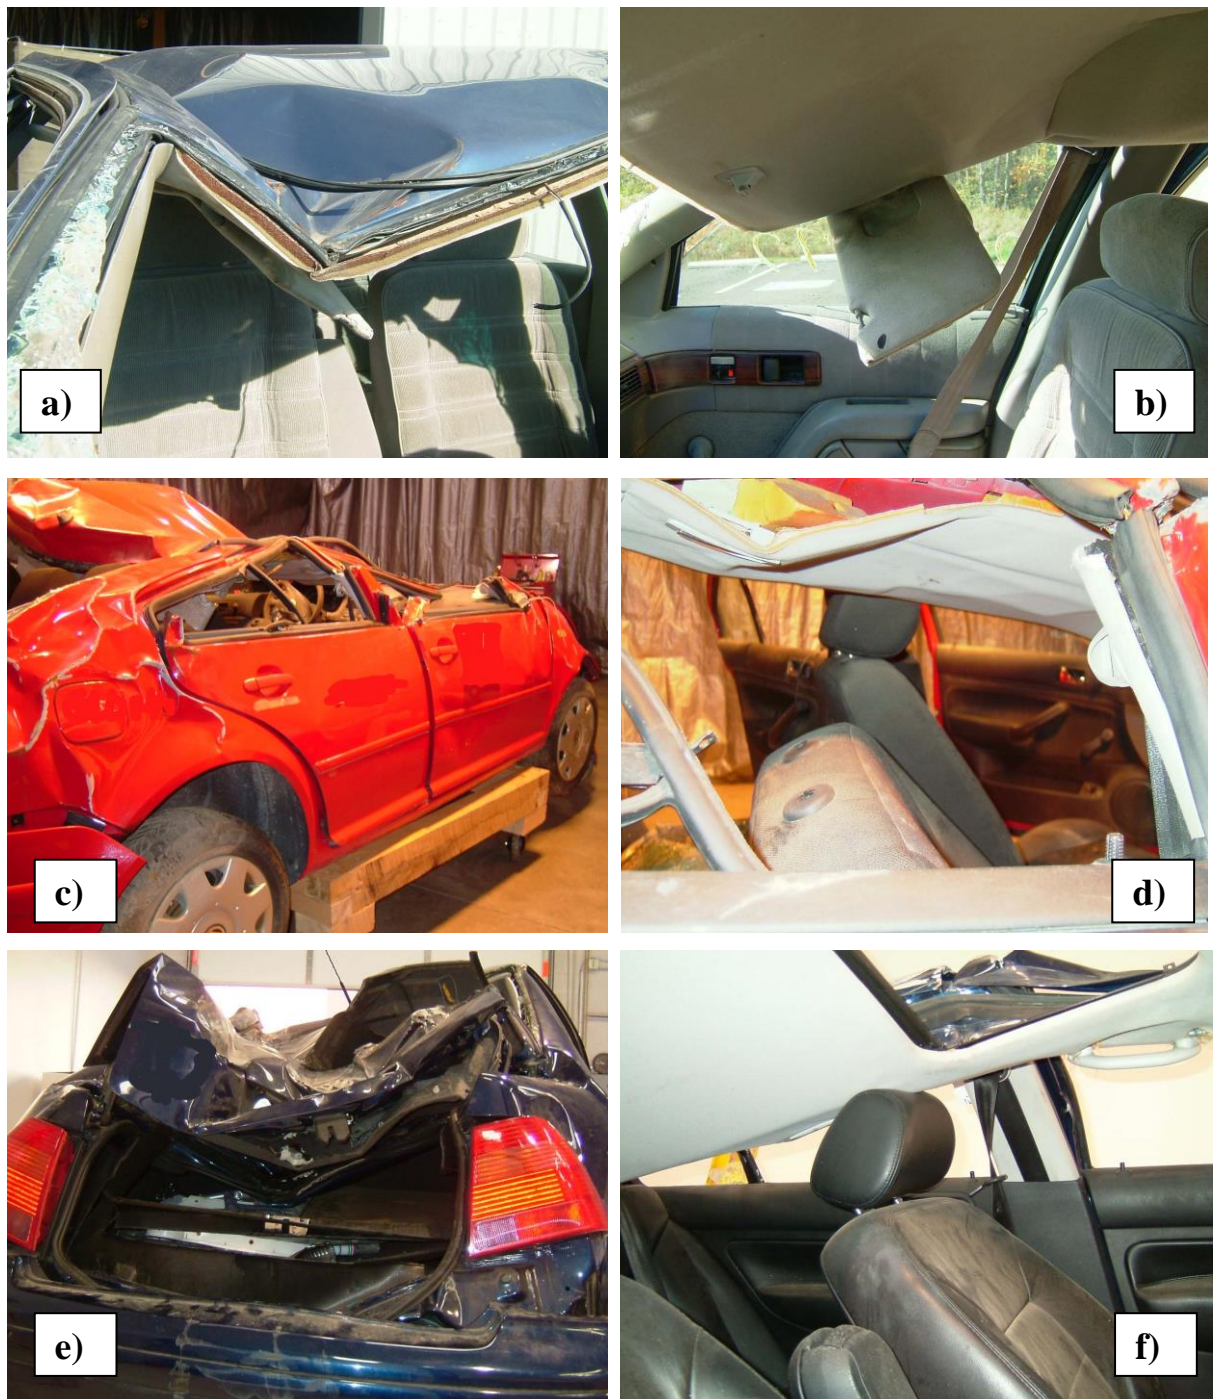
Figure 4. External view of roof deformation and internal view of roof intrusion

Figure 4a and Figure 5 can be used to assess these typical collapse mechanisms. Overall the roof final collapse pattern can be summarised as follows:

- (i) Predominantly the upper A-pillar on the near side (rollover leading side) of the front passenger seat bent inwards towards the occupant safety cell in a form of a cantilever collapse with a plastic hinge forming at about 1/3 of the distance from the upper A-pillar and lower A-pillar joint;

- (ii) The side roof rail on the near side remained almost parallel to its original form with small bending indentations that were localised;
- (iii) The front roof rail collapsed inwards into the occupant safety cell taking with it the roof that is weak to loads applied outside its plane. The maximum roof deformation is 215.9 mm that is a roof intrusion of about 74% above the headrest of the front passenger seat. The roof intrusion diminishes in magnitude along a line following the global longitudinal axis resulting in its minimal collapse near the right upper C-pillar. The residual headroom at the maximum roof intrusion was 76.2 mm.

- (iv) Damage was also noted on the driver side. However, this was extrusion rather than intrusion. The advantage of having an extrusion failure mechanism is that it delays the head roof contact time hence resulting in very small impulsive loads that may or may not impose injuries to the head-neck system.

The other physical measurements that aided the construction of the final failure mechanism of the roof collapse in Figures 4a and 5 are the internal intrusion readings. The images clearly show the extent of intrusion with the maximum deformation at the front roof rail directly above the front passenger's head (Figure 4b). The occupant in the passenger seat (right) had permanent disability paralysed from neck down. This assessment deduces that the roof is not strong enough to carry the vehicle load under rollover. Similar failure mechanism can be seen in Figure 4c to Figure 4f, however with greater roof intrusion.

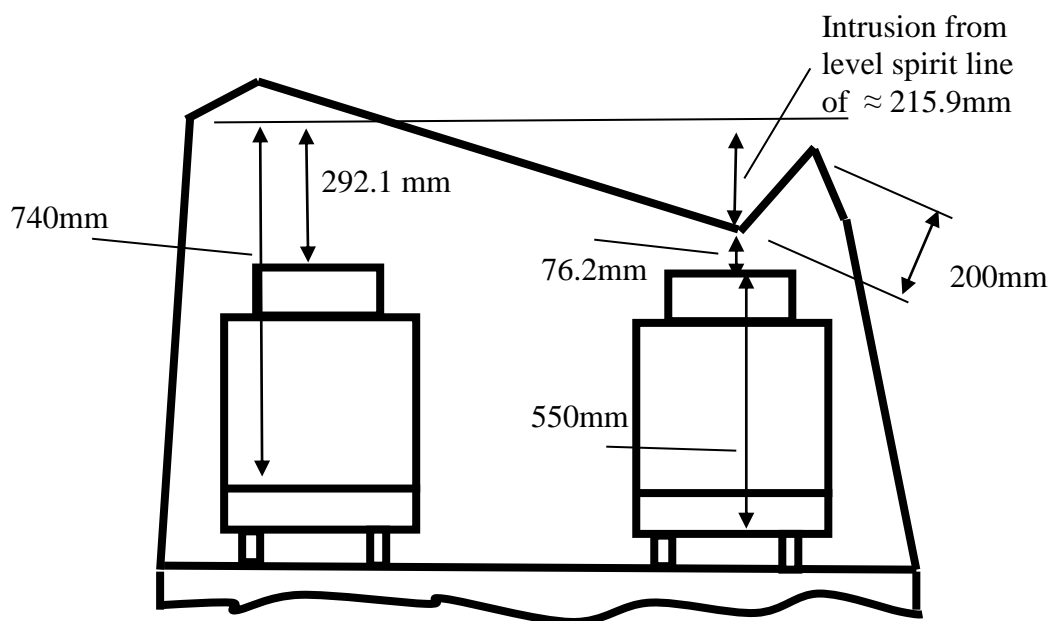
Figure 5. Schematic diagram depicting the roof structural deformation pattern for vehicle (Figure 4a) and seat positions – view from the rear to the front (Not to Scale)

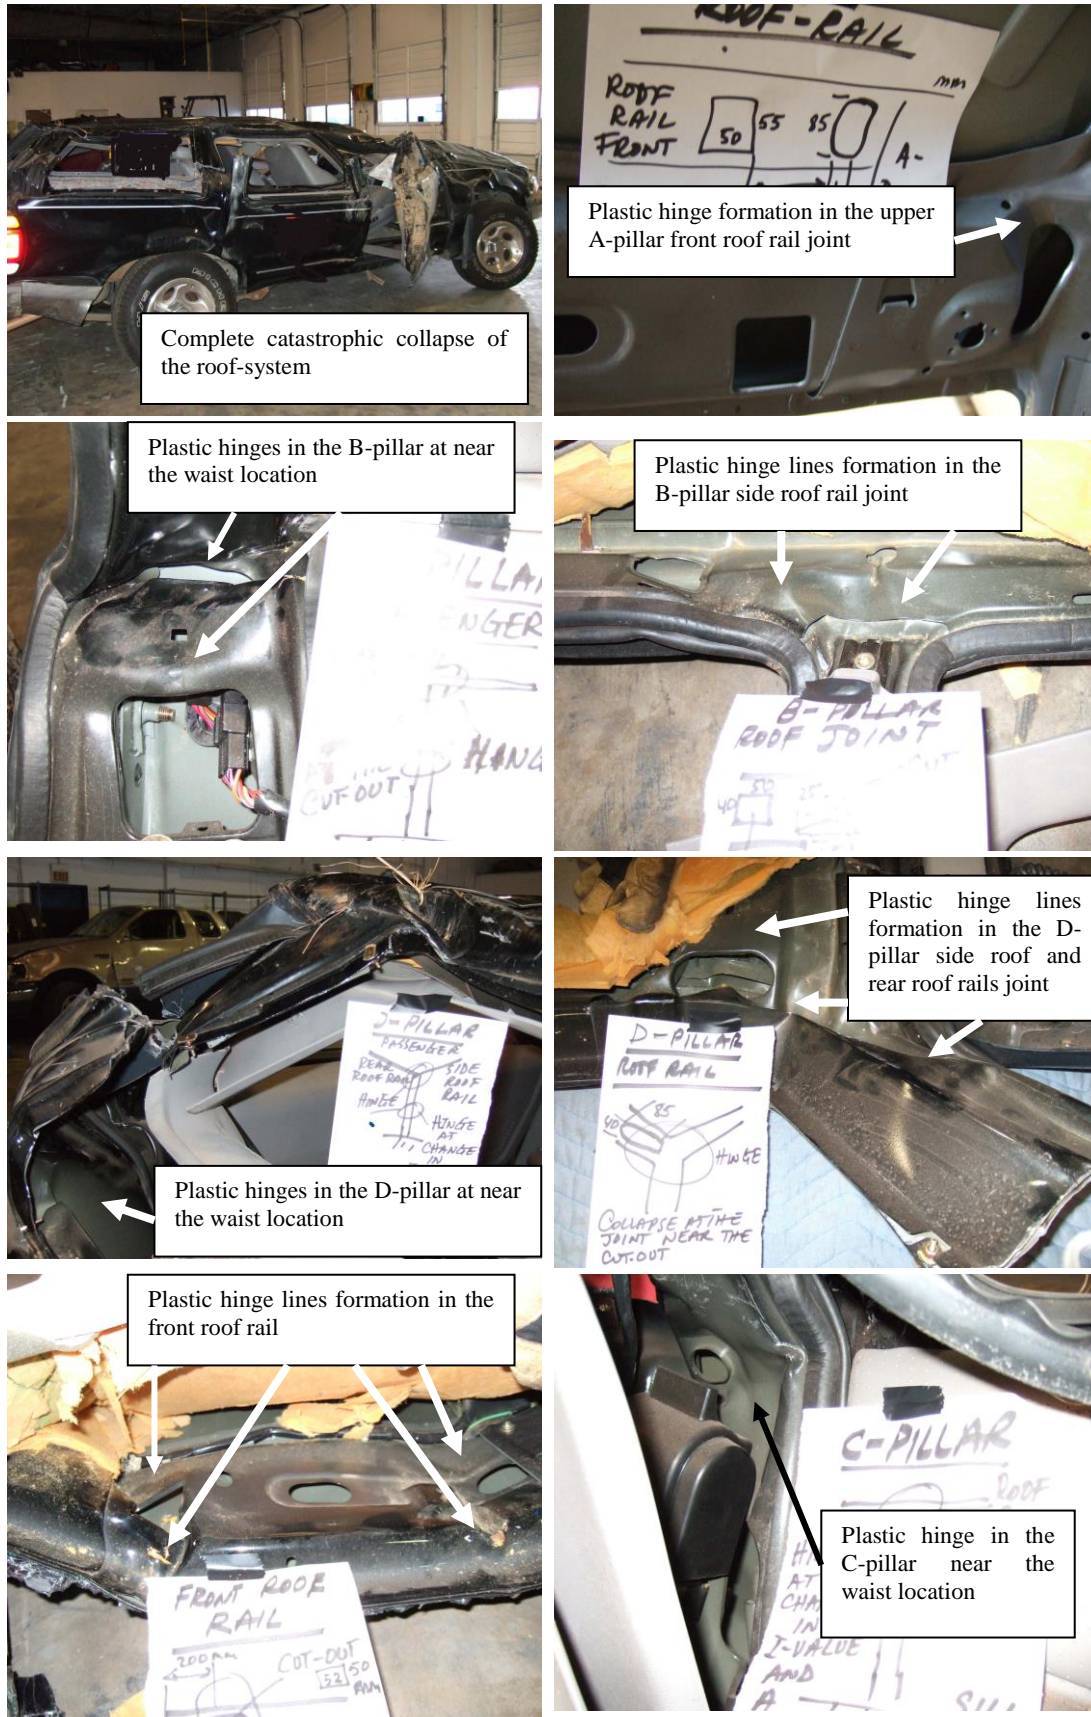
Figure 6. Collapse mechanisms occurring at cut-outs locations in a typical SUV under rollover

In analysing images in Figure 6, it can be seen that this SUV had a complete collapse of its roof because of poor design principles employed by manufacturers. Similar near identical collapse mechanisms have been observed in vehicles within the NASS cases.

The question is why the above vehicle roof (Figure 6) and those SUVs in the NASS cases had roofs collapse that were catastrophic in real world accidents when they had passed [15] the FMVSS 216 that yielded a complete different collapse mechanism with little intrusion showing only the lozenging effect of the roof-system with some cracking of the windscreen? The answer to the question is that the FMVSS 216 and the updated new FMVSS 216 are not representative test protocols that simulate real world accident scenarios in rollover. The work in [12, 15-17] demonstrate clearly that under the FMVSS 216 test procedures, the vehicles are loaded in such an orientation as to give artificial strength that is not experienced in real world accident cases.

The SUV in Figure 6 has also shown some of the worse pillar design philosophies. All important load bearing pillars including some roof rails are excessively perforated and have cut-outs so large that the whole roof-system is tremendously weakened. No wonder the resultant collapse mechanism seen in Figure 6.

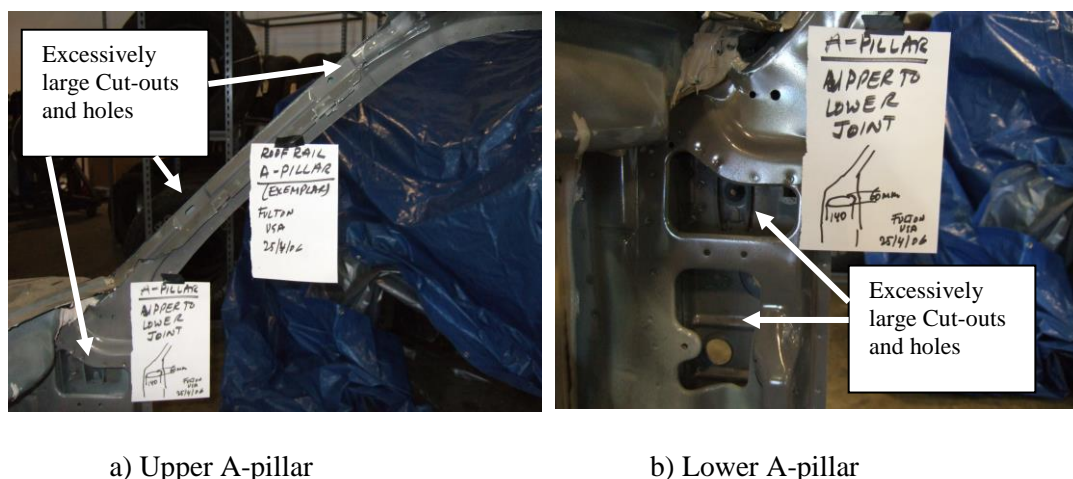
The upper and the lower A-pillars (Figure 7) have large cut-outs and perforations at strategic locations where they are weakening the pillar system. The whole upper A-pillar is strong along its length, but has poor joint design with large holes just in positions of strategic importance in terms of load carrying capability and load transfer.

Figure 7. The upper and lower A-pillar showing cut-outs at strategic locations for load bearing capability

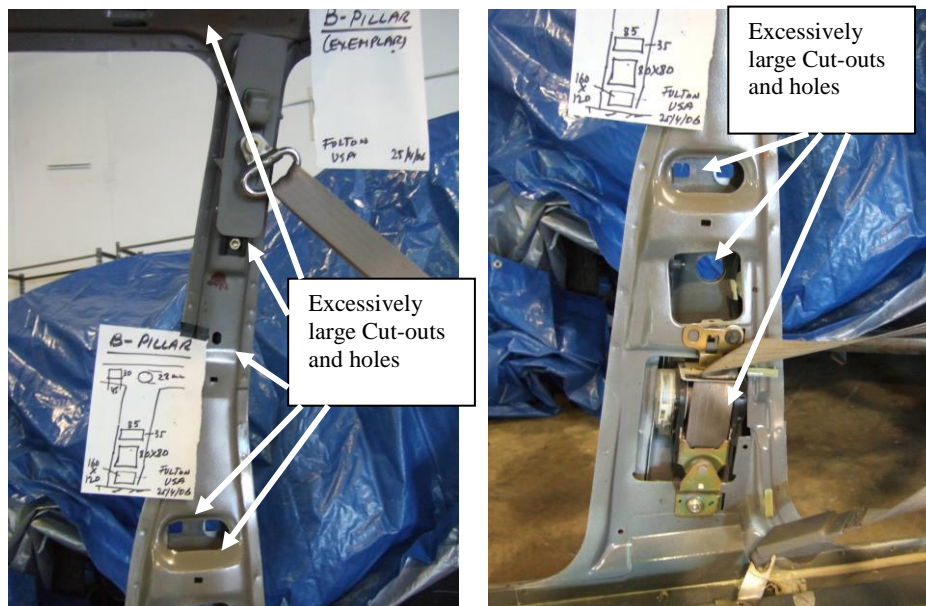
The B-pillar too in Figure 8 has not been thoughtfully designed. The principles of design employed in this B-pillar are flawed as excessive large cut-outs are located in areas that require resisting maximum loading. In Figure 6, the B-pillar is shown to collapse at near the waist line where the large cut-outs are as shown in Figure 8. The B-pillar is full of cut-outs and holes that have diminished the capability of not only being good at transferring load, but have also eliminated adequate occupant protection in side impact.

Figure 8. The B-pillar showing cut-outs that diminish the capability of the pillar

What is not clear is the rationale manufacturers employed in designing such B-pillars when in rollovers the impact is applied at the B-pillar roof joint. In such situations, the B-pillar must be able to perform well in bending (Figure 6) as a cantilever with the maximum bending moment at the waist line. How can a proficient engineer locate a cut-out at that precise location experiencing the maximum bending moment? This reasoning is beyond comprehension and inexcusable. Indeed, the design must

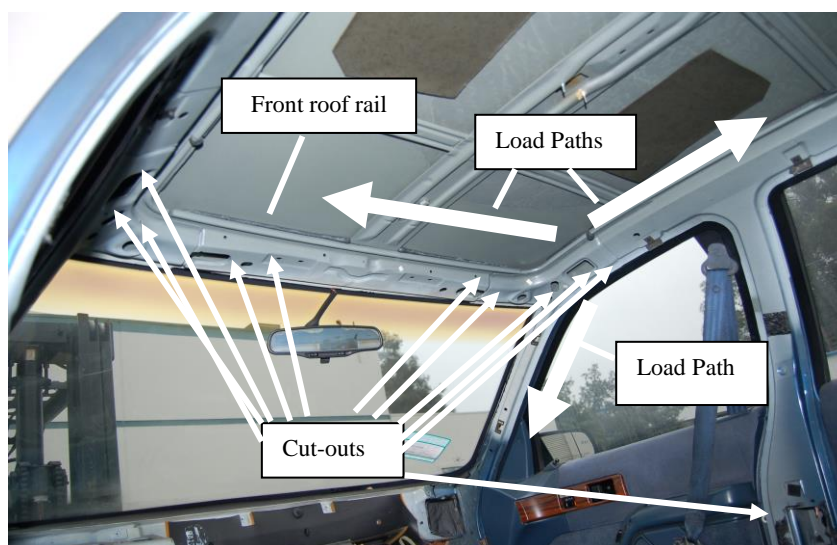
Many SUVs have similar designs. However, this rationale in the design of excessive cut-outs is not only seen in SUVs. Many passenger vehicles also have similar problems that need rectifying. For instance, the vehicle in Figure 9 shows a typical family saloon or sedan car that is poorly designed.

Figure 9. The roof-system of a passenger car showing cut-outs and intended load paths

If the rails have cut-outs, then their ability to transfer that load quickly and effectively is compromised and as a result inevitably weakened. Figure 9 shows the number of cut-outs in the front roof rail to be unacceptably high and hence the front roof rail remains highly impact sensitive. Figure 9 also shows the sudden changes in stiffness and strength caused by these cut-outs often give rise to undesirable stress concentrations.

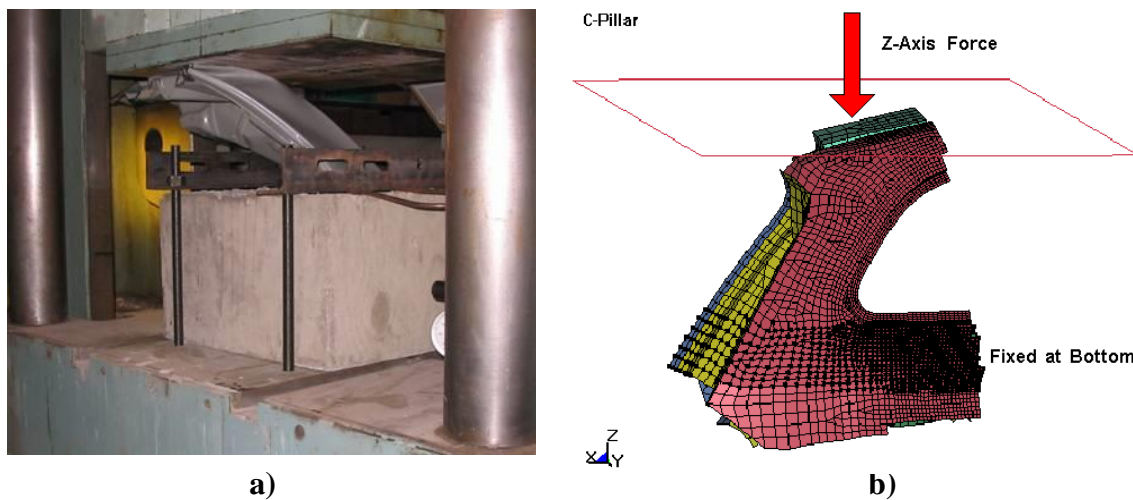
It was also necessary to quantify the amount of loss in strength when a cut-out has been introduced in a pillar design. Figure 11a shows a typical C-pillar of a passenger car that was tested experimentally, and then modelled without and with a cut-out (Figures 11b and 12a). The results are given in Figure 12d.

The C-pillar (Figure 11a) was mounted in a concrete block that was fixed in all degrees of freedom employing a specially designed jig. The load was then applied through a bar that had a built-in load cell to record the load resistance. The experimental tests were followed by the finite element modelling of the C-pillar as shown in Figure 11b.

Figure 11. C-pillar under combine bending and compression experimental test and FE model

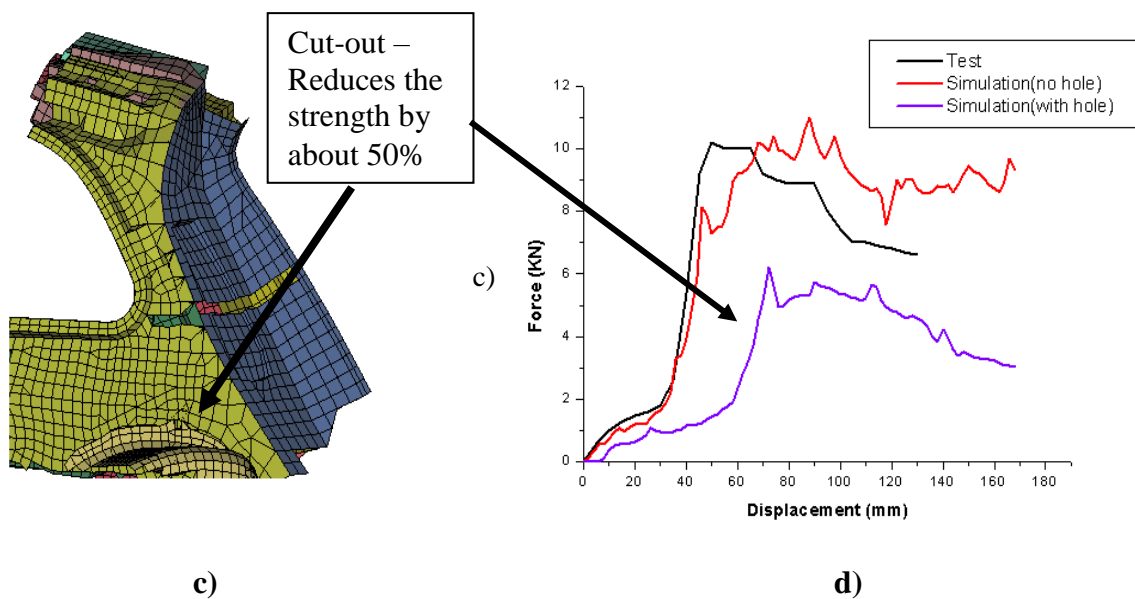
After the simulation of the C-pillar without a cut-out was successful depicting good agreement with the experimental results, it was necessary to model the same C-pillar but this time with a cut-out (Figure 12a) in the same location as in some of the vehicles with side airbags. The cut-outs in the C-pillars of these vehicles act as access for pipes leading to the energising chamber stored in the boot regions.

Figure 12. C-pillar FE analysis with a cut-out and the results for comparison

It is clear that the hole or the cut-out introduced in the C-pillar is causing a lot of concern. The maximum C-pillar strength in this case is reduced by 50% when the cut out is introduced. This finding is important to designers who excessively introduce cut-outs in their designs for whatever purpose. The 50% reduction is shown when one cut-out is introduced. When many cut-outs are designed-in, the strength reduction can go all the way to 80%. This is the phenomenon observed in the SUV presented in Figure 6.

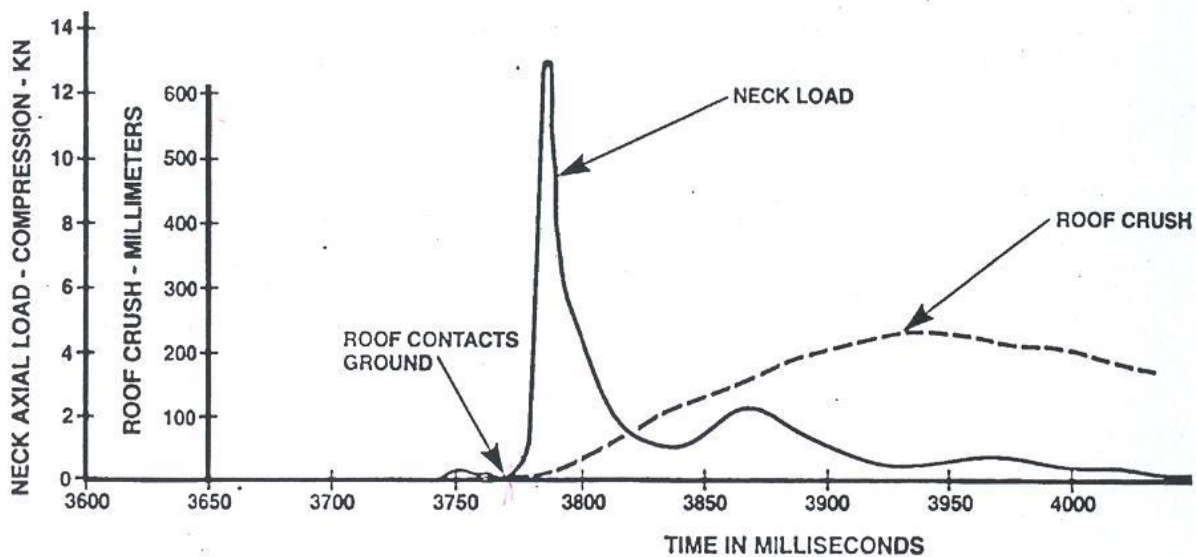
To enable the proof be derived, it was necessary to use Figure 13 on page 108 of the original test 7L4 conducted on a 1983 Chevrolet Malibu vehicle with production roof [10]. This particular test was chosen because it produced the highest neck load 13.2 kN according to reference [10]. This graph attributed from the results is reproduced herein as Figure 13.

Figure 13. Roof crush and neck load vs time driver impact 7L4 [10]

Before the re-analysis of the Figure 13 could be made, it is necessary to mention that the authors have had no access to the video material released into the public domain by General Motors. The only exposure to the video material is the analysis made from the results presented in [11]. Therefore, re-analysis being carried out here for the proof purposes is solely based on the test result characteristics published in Figure 13 of reference [10].

- (i) First Figure 13 [10] was digitised using a digitising software at very small intervals in order to increase the accuracy of the translation from analogue to digital;
- (ii) Both neck loads and roof crush data were saved in ASCII format and imported into Matlab suite;
- (iii) The crush data and the neck load characteristics were plotted;
- (iv) The crush characteristic was then differentiated once to get the velocity;
- (v) Then the velocity curve was differentiated once more to get the roof acceleration characteristic;
- (vi) After plotting all the curves, neck load, roof crush, roof velocity and roof acceleration to the same time scale (Figure 14), a picture began to emerge showing what we always suspected.

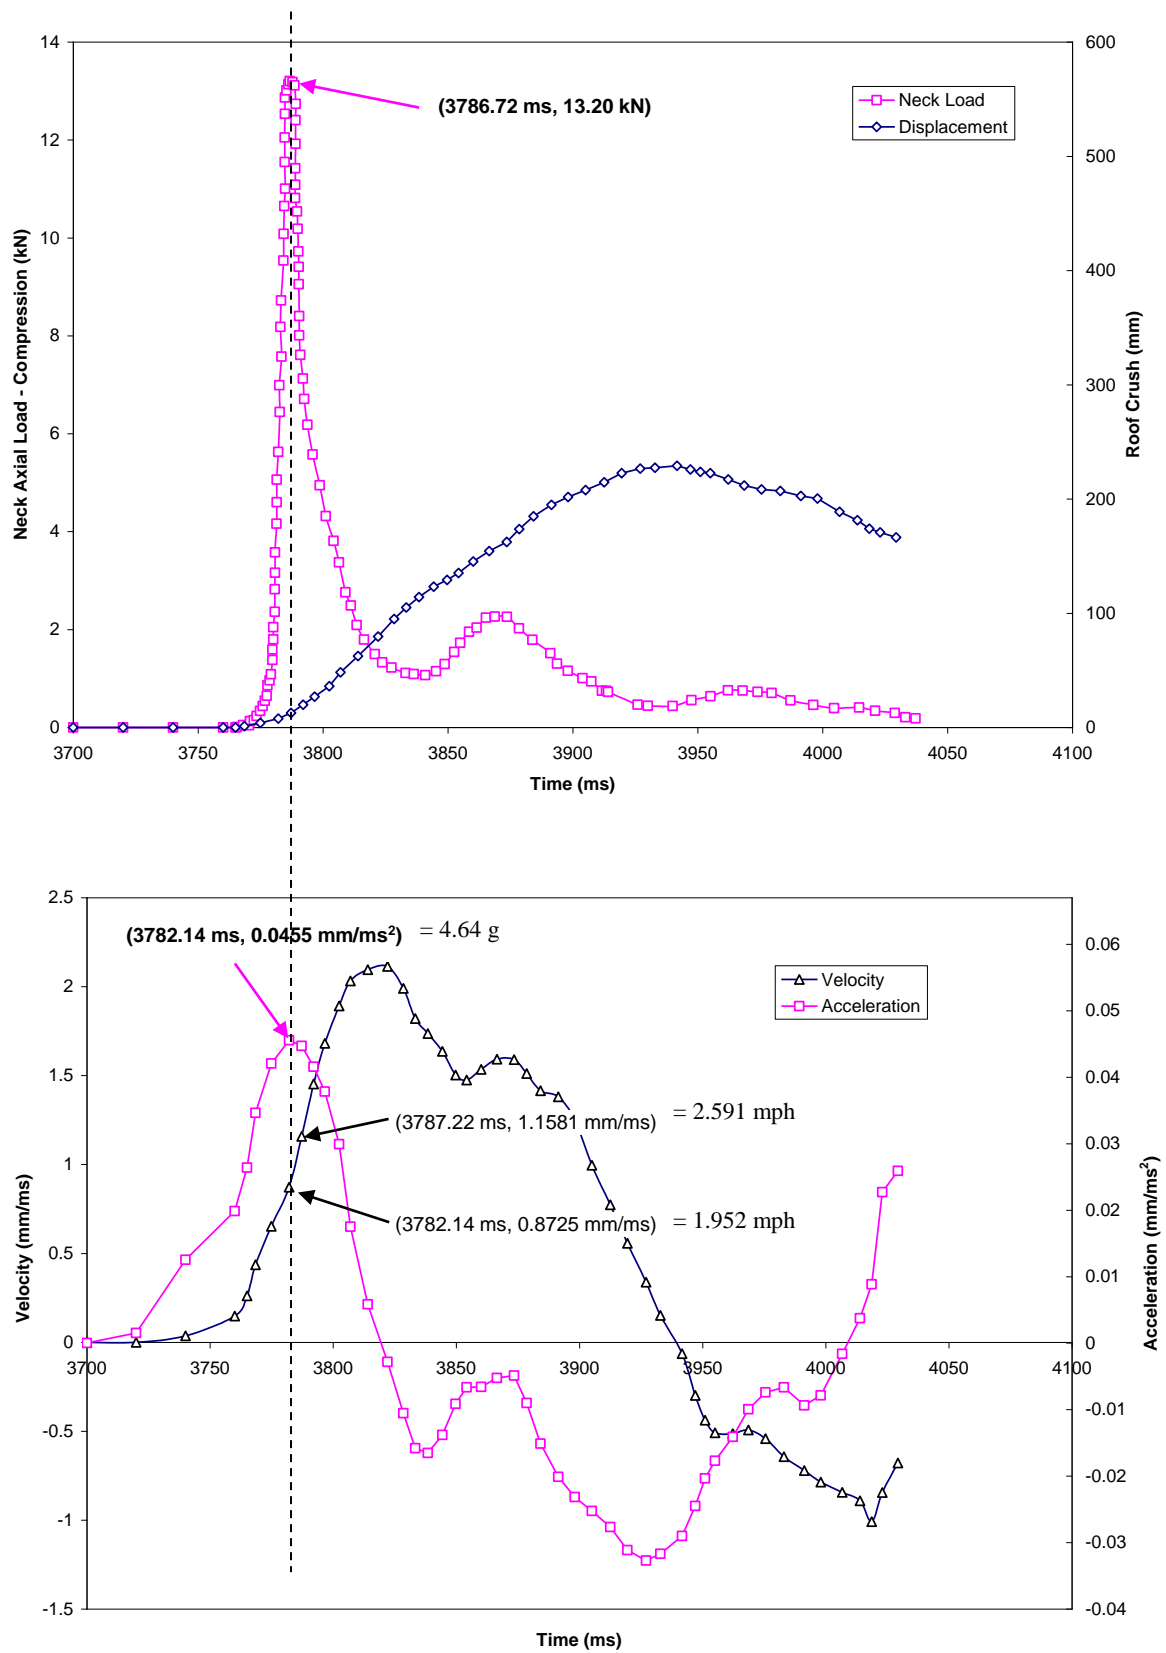
Figure 14. The digitized test 7L4 (Figure 13 [10]) results depicting acceleration and velocity derived from the differentiation of the roof crush curve

Analysis of the curves plotted to the same time interval (Figure 14):

- (vii) The most important finding of them all is the roof acceleration peaking at precisely the same time as the maximum neck load. This means that the roof was accelerating at the time it made contact with the dummy's head. The acceleration value can be derived from the acceleration characteristic that has been drawn from the twice differentiated roof crush curve. The results show that the head contact occurred when the roof was accelerating into the safety cell at maximum value of $0.455 \text{ mm/ms}^2 = 45.5 \text{ m/s}^2 = 4.64 \text{ g}$.
- (viii) At that same time when the roof was accelerating at 4.64 g, the rate of roof intrusion was $0.8725 \text{ mm/ms} = 0.8725 \text{ m/s} = 1.952 \text{ mph}$. This shows that the roof was intruding, separated from the ground when the maximum force of 13.2 kN was imposed in the dummy's neck.

The re-analysis carried out here on the test 7L4 results shown in Figure 14 depicts a complete different scenario and series of events. According to the roof acceleration, roof velocity and roof crush characteristics in Figure 14 it can be clearly seen that the peak roof acceleration and the peak neck load occur at precisely the same time. At this same time the roof rate of intrusion is not equal zero as the case may be when the roof is against the ground, but equal to 1.952 mph. The roof at this moment in time has therefore practically separated from the ground and every contact made between it and the dummy's head is entirely with the inward accelerating roof.

The re-analysis also shows that the roof was increasing in speed as it intruded and rate of increase was high. The finding can be better shown by taking two points on the velocity curve. One point is taken at precisely 3782.14 ms when the acceleration is maximum and the velocity reading is 0.8725 m/s or 1.952 mph. The other point is taken at a time 5.08 ms after and the velocity reading is 1.158 m/s or 2.59 mph. The change in velocity during this extremely small change in time is 0.64 mph. That is termed as high for the duration that is very small duration.

The findings herein throw out the "diving theory" that has dominated the philosophy of roof design under rollover. The roof acceleration and roof velocity curves in Figure 14 prove that the dummy received serious head-neck injuries only after the roof had contacted the ground and the roof was crushing at an intrusion rate of 1.952 mph. It is not correct to suggest otherwise, even to say that the neck load occurred prior to roof crush.
