Commercial, Police, and Military Vehicle Rollover Protection and Evaluating the Effectiveness of Geometry and Retrofit Rollover Testing

Abstract: Rollover crashes cause more than 10,000 fatalities and nearly 30,000 serious injuries per year in the U.S. alone. This is due to the fact that the vast majority of vehicles, including commercial, police, and military, lack the roof strength to preserve occupant survival space and protect their occupants in a rollover. Recent statistical and epidemiological studies have shown a significant relationship between roof crush and injury. This rollover occupant protection problem is well known to industries with large vehicle fleets; until now, this problem has eluded solution. Within these various industries a wide variety of rollover occupant protection systems (ROPS), both internal and external, have been designed, purchased, manufactured, installed, and maintained locally with little expert consultation. A wide variety of designs have emerged with an alarming variance in "assumed" crashworthiness. Couple this alarming trend with the risk of rendering the existing occupant protection features (e.g., airbags) ineffective, which has resulted i

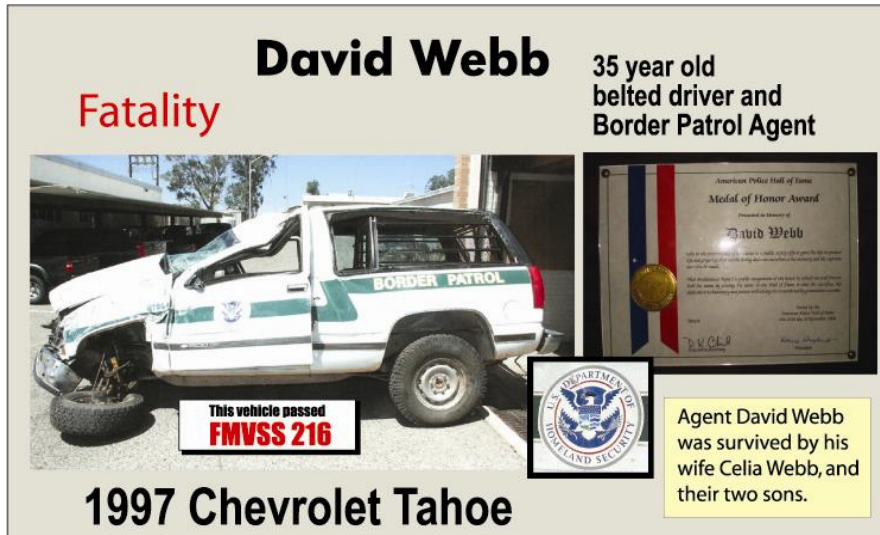
David Webb¹⁵ was a 35 year-old Border Patrol agent out on a routine call when the right rear tire of his 1997 Chevrolet Tahoe blew out. This caused him to lose control and his SUV rolled over. He sustained a fractured skull and never regained consciousness. Figure 1 shows the vehicle with roof deformation at the driver-side A-pillar, after the crash. It is worth noting that the aftermarket roll cage in the rear for detainees was the section of the vehicle that did not crush.

Figure 1. Government vehicle rollover victim (image from www.peoplesafeinrollovers.org)

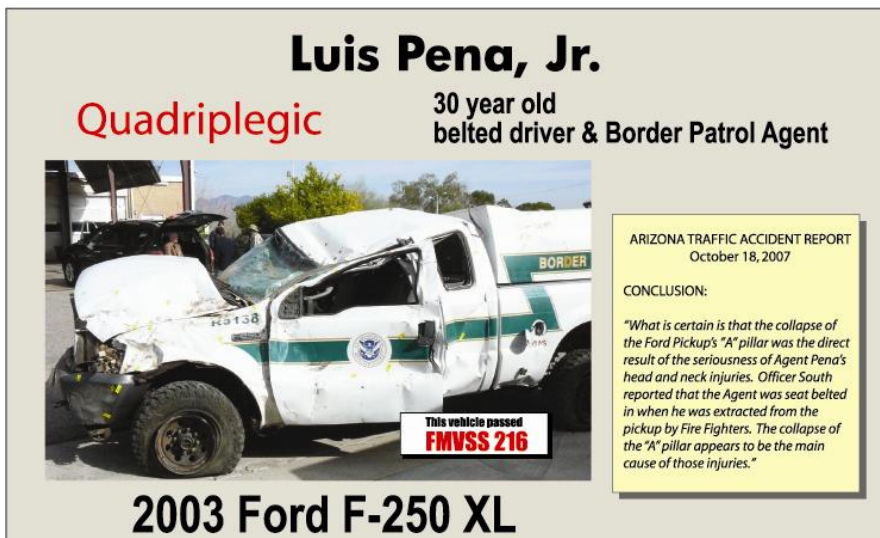
The other victim was 30 year-old Border Patrol agent, Luis Pena, Jr.¹⁶ Mr. Pena was amnesic to the event, but speculates that he may have tried to avoid hitting either a horse or cattle when his 2003 Ford F-250 XL rolled over. His injuries included vertebral dislocation with spinal cord injury, rendering him quadriplegic. Figure 2 shows the roof crush at the driver-side A and B-pillars.

Figure 2. Government vehicle rollover victim (image from www.peoplesafeinrollovers.org)

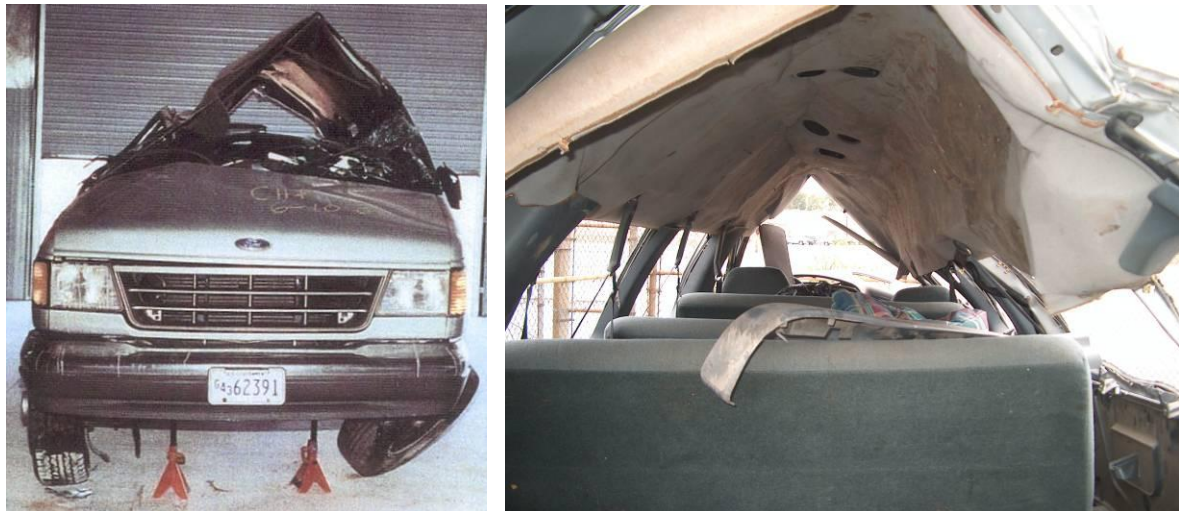
A volunteer driver departed Camp Wilson in route to Laughlin, Nevada, with 15 Marine Corp passengers. The Ford Club Wagon Van had a tire blow out, which caused a loss of control and vehicle rollover. This vehicle sustained multiple impacts to the roof, rear and both sides. There was a significant impact to the right roof and upper right side which caused significant intrusion into the right side of the passenger compartment. This major impact to the roof had a principal direction of force from top to bottom and right to left. Figure 3 shows the marine transport van after the crash; the exterior view is on the left and the interior view from the rear is on the right.

Figure 3. Military vehicle fleet - U.S. Marine transport van case study

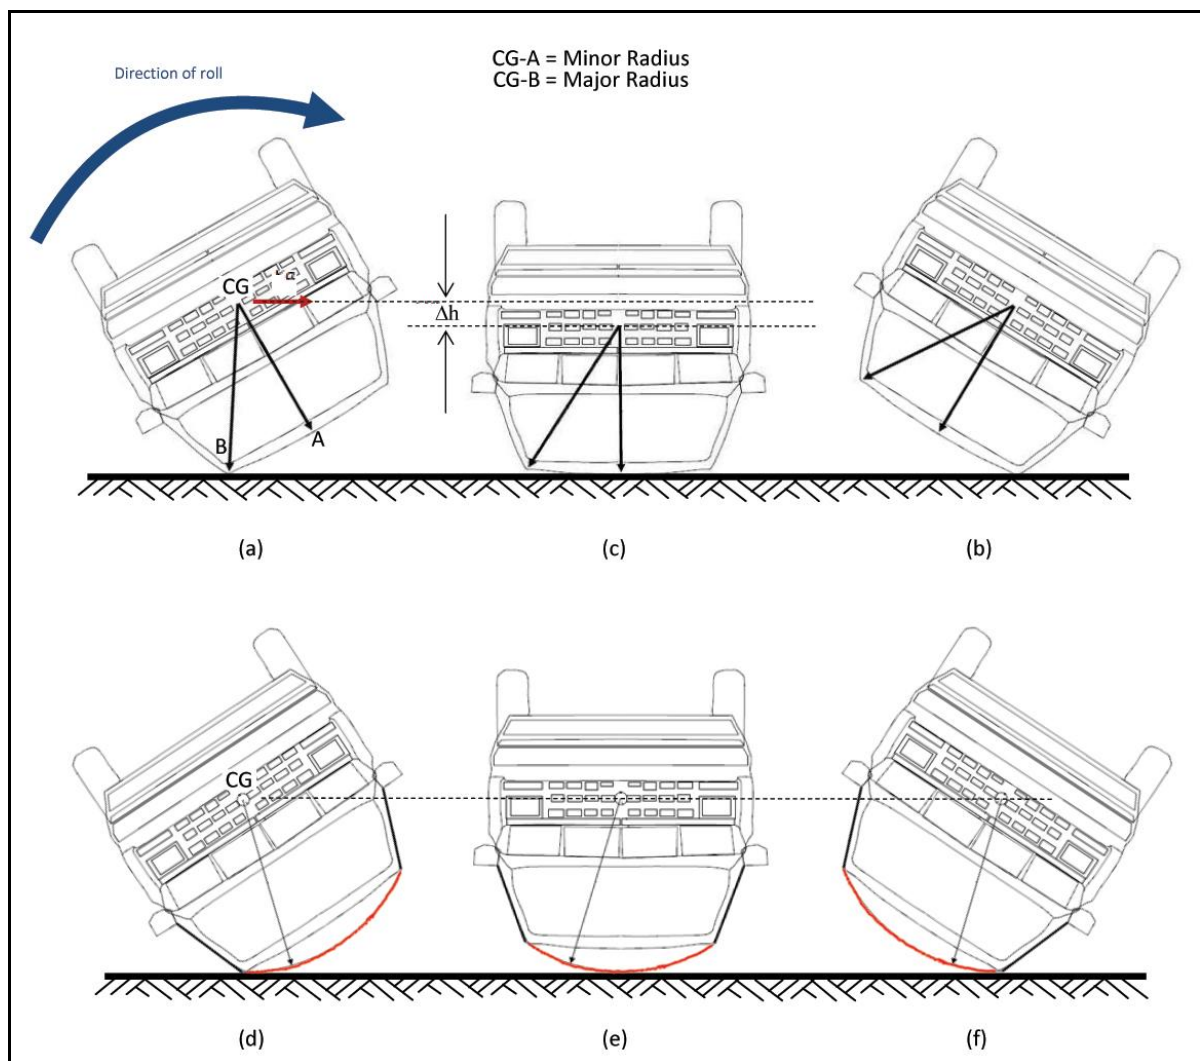
Grzebieta et al (2009)¹² demonstrated a ‘proof of concept’ how roof crush intrusion into the occupant compartment can be prevented using an innovative externally retrofitted rollover load distribution device. It was developed based on an understanding of how vehicles roll and roofs crush during rollover. It incorporates a roll “hoop” placed in line with the major radius of the vehicle changing and improving the vehicle geometry. Figure 4 demonstrates via sketches the concept of this process.

Figure 4. Top row: Vehicle’s CG drops during rollover and then rises again;
Bottom row: Hoop maintains vehicle’s CG at constant height, thus reducing roof load

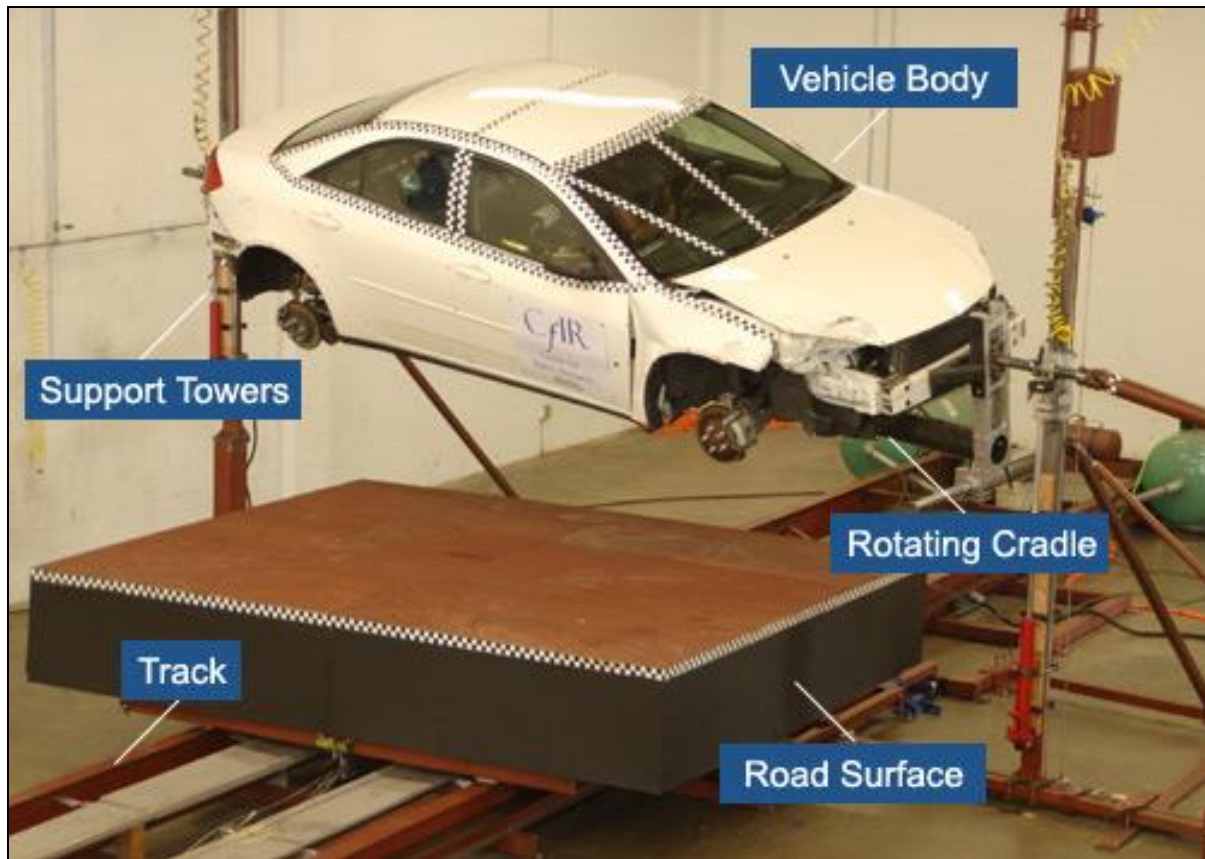
The JRS is shown in Figure 5. The Vehicle Body is mounted on the Rotating Cradle and then fitted into the Support Towers. The Road Surface is moved to the far end (not shown) of the Track. The Support Tower's release mechanism and the Road Surface trigger are synchronized to achieve the prescribed test parameters. The Road Surface moves down the track at the prescribed speed and the Vehicle Body is rotated and released to meet the Road Surface at the prescribed angle and roll rate, and arrested after each roll. Detailed descriptions of capabilities and operation of the JRS are published elsewhere.^{19,20,21}

Figure 5. Photograph of the major components of the JRS

The protocol used to test the HALO™ prototypes was performed with at least 2 passenger side leading rolls at 18 mph (29 kph) roadbed speed, a 222 °/sec vehicle angular rate, a 4 inch (10.2 mm) drop height and a 10° impact pitch angle, most of these parameters are more severe than those recommended by Friedman and Grzebieta (2009).¹² If there was a third roll conducted, the road speed was 15 mph (24 kph) and the pitch angle was 5°, with the same drop height and equivalent angular rate. The vehicles were equipped with Hybrid III 50th percentile dummy belted in the driver's seat. For each roll, the dynamic peak roof crush was tabulated, the end of test residual roof crush, and dynamic peak roof crush speed at the pillars and roof header.

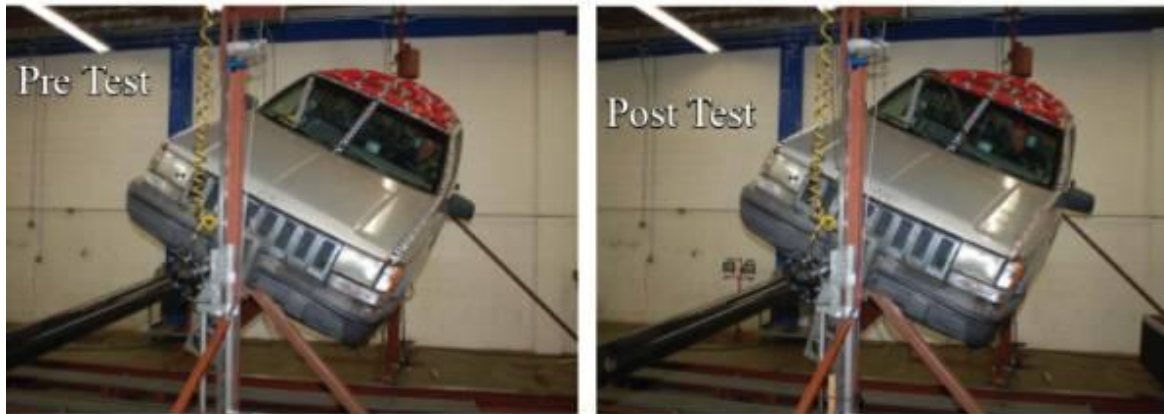
The second prototype of the HALO™ was a much more intricate design with multiple attachment points, a fully integrated interior B-pillar to B-pillar reinforcement and a fully redesigned exterior front. This prototype worked very well in reducing roof crush as shown in Figure 6. The vehicle struck the ground at 147° on the near side and cleanly rolled over the far side with very little apparent damage. The dummy was only lightly loaded during the test. The test results for prototype 2 are shown in Table 1.

Figure 6. HALO™ Prototype 2; No noticeable deformation to the roof structure

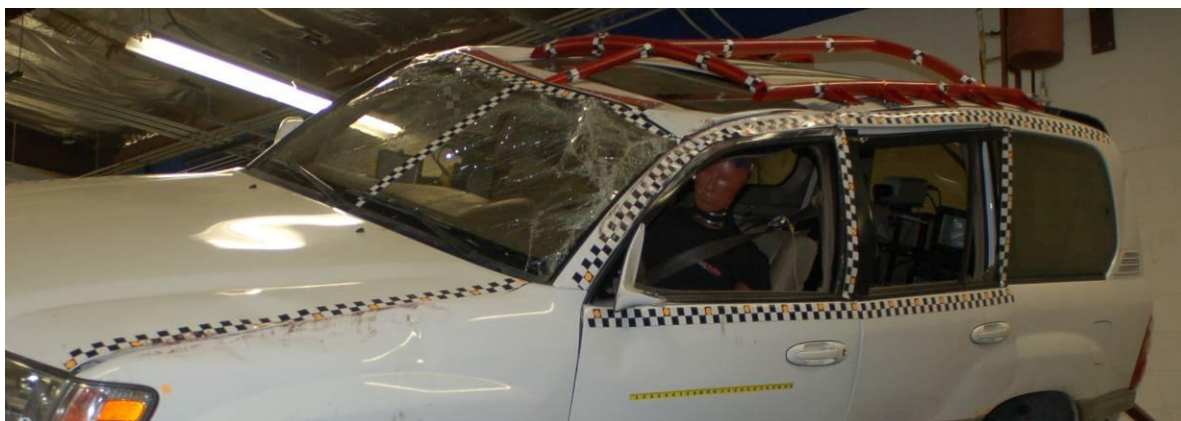
The third prototype of the HALO™ was a more simple design than the previous prototypes with a fully redesigned front. The HALO™ Prototype 3 on a different SUV was tested to check for differences in vehicle type performance and without the internal supports at the B-pillar. This prototype was not as successful in that the B-pillars had some buckling and the flat redesigned exterior front pushed in on the header more than considered acceptable as shown in Figure 8.

Figure 8. HALO™ Prototype 3 post-test photograph

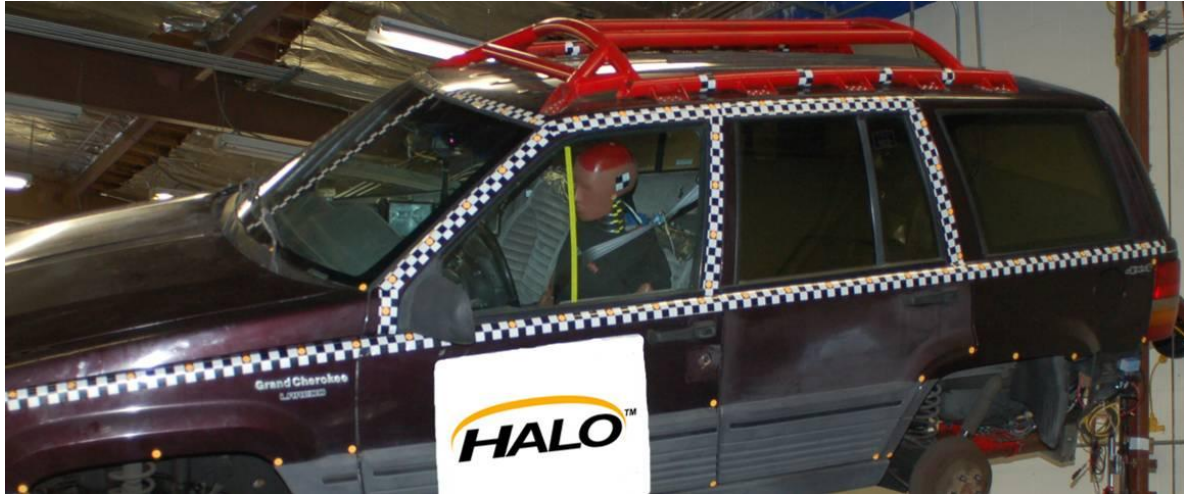
For the fourth prototype test the original SUV type used for prototypes 1 and 2 was used again. The redesign included the B-pillar reinforcement plates, dual longitudinal rails and a redesign of the piece in front of the roll hoop. The same protocol for testing on the JRS was used. Photographs of this design before and after each roll of a 3 roll test series are shown in Figures 9a-d below.

Figure 9a: HALO™ Prototype 4 pre-test photograph

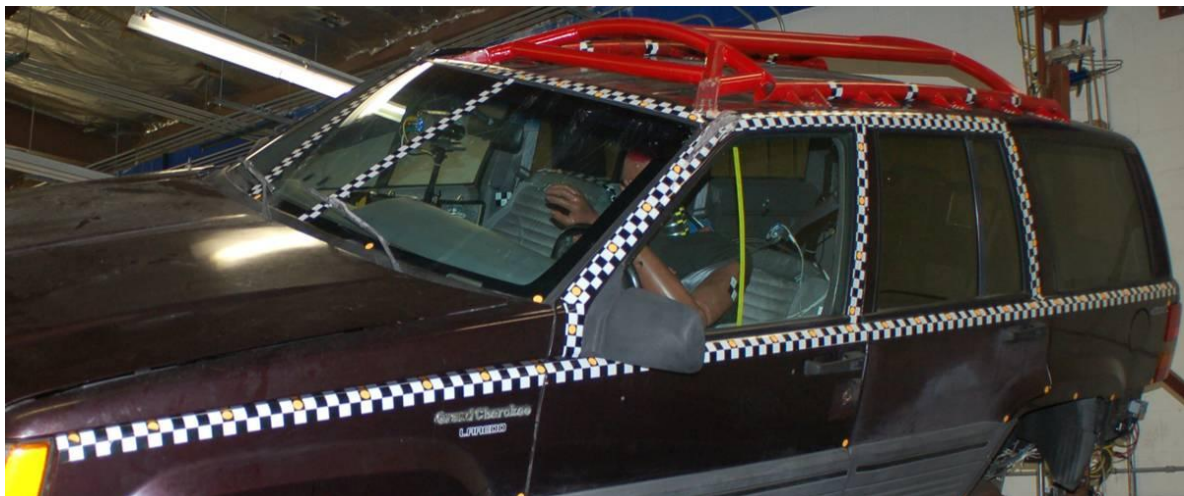
HALO™ prototype 4 performed very well in a three roll series of tests. The first roll was conducted with an 18 mph (30 kph) road speed, 10° of pitch and 145° roll contact angle. The resultant measurements of roof displacement are shown in Table 2. Figure 9b is the post-test photograph.

Figure 9b. HALO™ Prototype 4 Roll 1 post-test photograph

Prototype 4 ROLL 1	Peak Roof Crush (in)	Peak Roof Crush (mm)	End of Test Roof Crush (in)	End of Test Roof Crush (mm)	Peak Roof Crush Velocity (mph)	Peak Roof Crush Velocity (kph)
A-Pillar	-0.8	-19.4	-0.2	-4.6	1.0	1.6
B-Pillar	-0.2	-5.6	0.2	4.7	0.7	1.2
Roof Header	-0.8	-21.4	-0.3	-7.9	1.5	1.3
Near Side A-Pillar	-0.9	-23.2	-0.3	-7.5	1.6	2.6

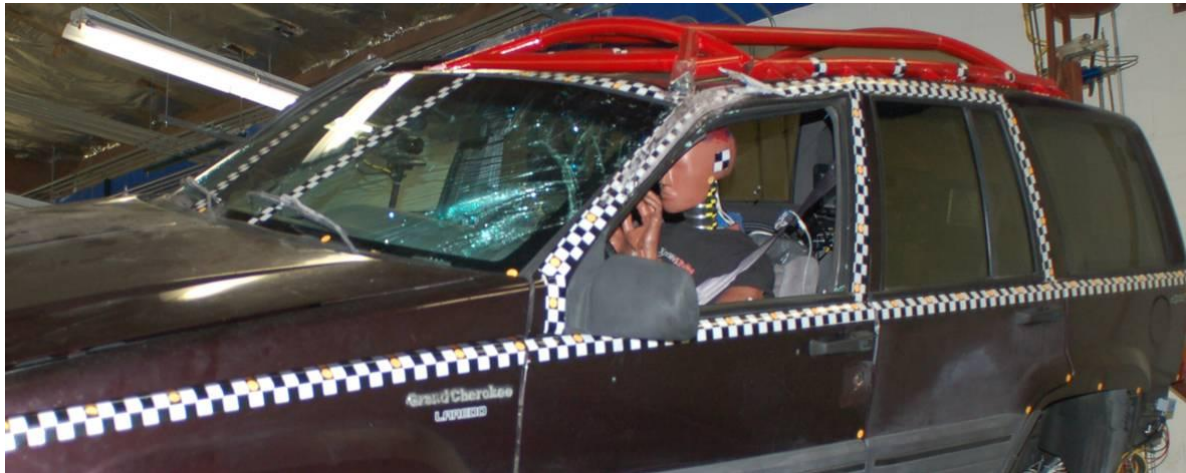
The second roll was conducted with an 18 mph (30 kph) road speed, 10° pitch and 145° roll contact angle. Table 3 lists resultant roof displacement measurements. Figure 9c is the post-test photograph.

Figure 9c. HALO™ Prototype 4 Roll 2 post-test photograph

Prototype 4 ROLL 2	Peak Roof Crush (in)	Peak Roof Crush (mm)	End of Test Roof Crush (in)	End of Test Roof Crush (mm)	Peak Roof Crush Velocity (mph)	Peak Roof Crush Velocity (kph)
A-Pillar	-2.1	-52.1	-1.1	-27.0	2.0	3.2
B-Pillar	0.0	-0.5	0.5	11.5	0.7	1.2
Roof Header	-1.8	-46.6	-0.8	-19.8	1.5	2.4
Near Side A-Pillar	-1.4	-35.2	-0.5	-12.6	1.3	2.2

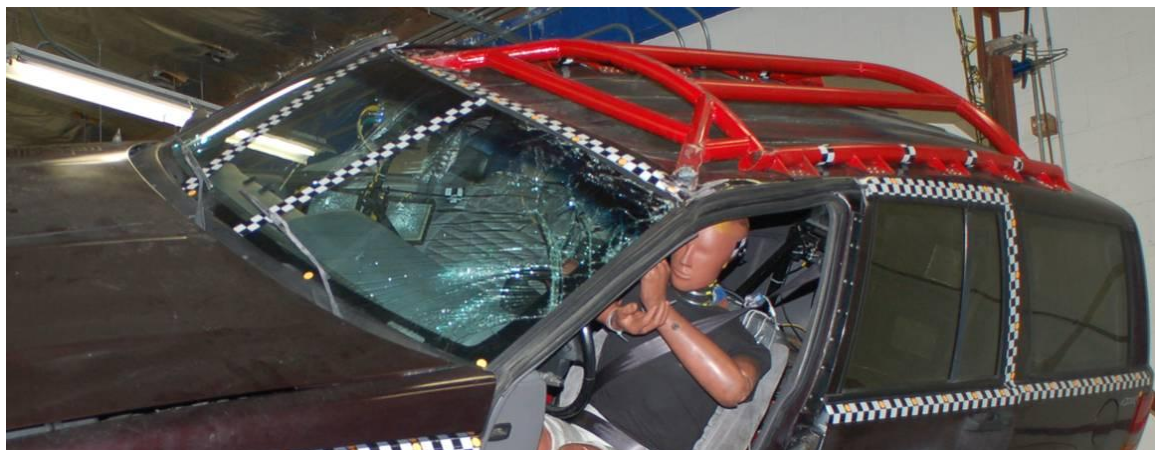
The third roll was conducted at a 15 mph (24 kph) road speed, 5° pitch and 135° roll contact angle. Table 4 lists resultant roof displacement measurements. The post-test photograph is Figure 9d.

Figure 9d. HALO™ Prototype 4 Roll 3 post-test photograph

Prototype 4 ROLL 3	Peak Roof Crush (in)	Peak Roof Crush (mm)	End of Test Roof Crush (in)	End of Test Roof Crush (mm)	Peak Roof Crush Velocity (mph)	Peak Roof Crush Velocity (kph)
A-Pillar	-1.8	-45.0	-0.4	-10.7	2.4	3.9
B-Pillar	-0.7	-17.6	0.1	3.4	1.1	1.8
Roof Header	-1.8	-46.6	-0.5	-11.6	1.6	2.6
Near Side A-Pillar	-1.4	-36.2	-0.2	-6.3	1.8	2.9

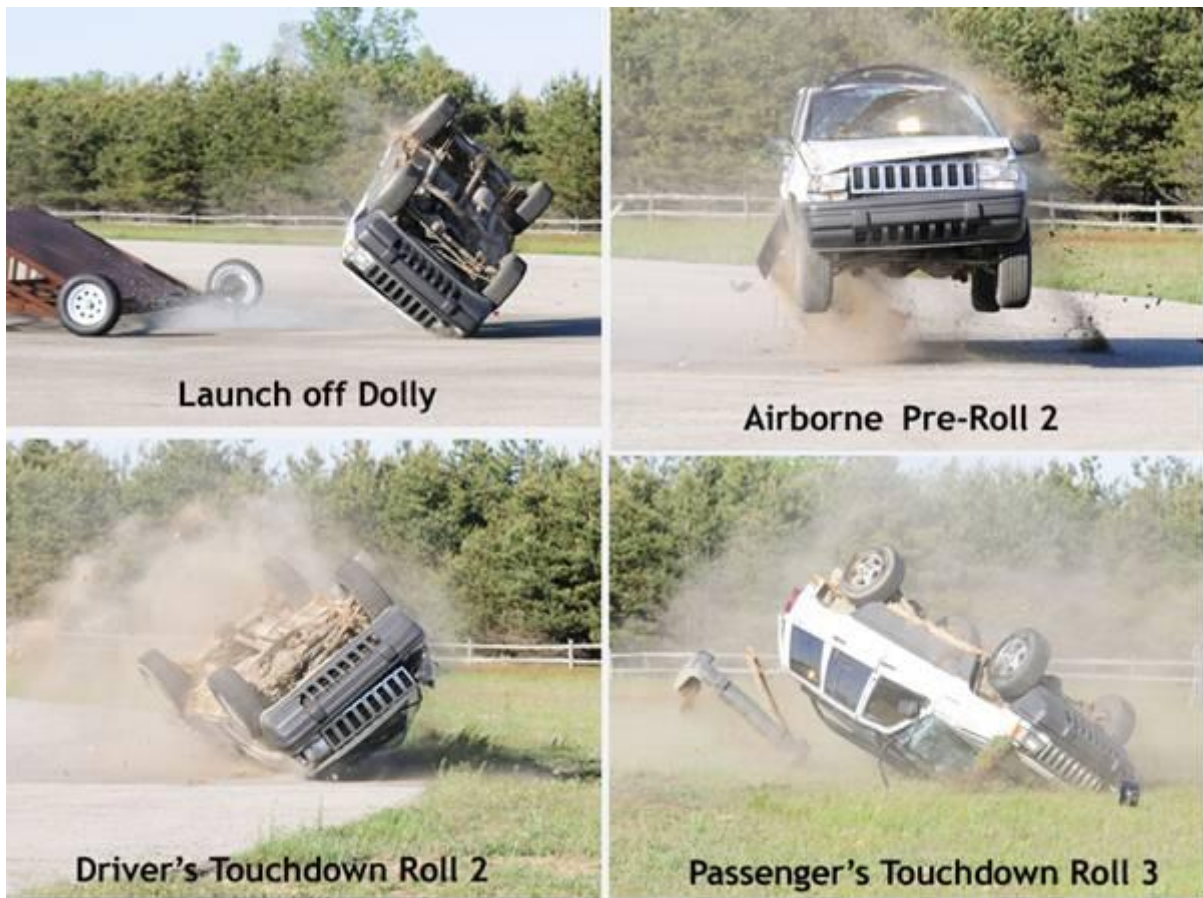
Finally, a dolly rollover test was performed with HALO™ Prototype 4 on a 15 year-old, high-mileage, somewhat-rusted, used vehicle. The test was conducted at 42 mph (68 kph) off the dolly, which was more severe than FMVSS 208. A sequence of photographs from the test is shown in Figure 10.

Figure 10. HALO™ Prototype 4 during a FMVSS 208 dolly rollover test

The various videos were reviewed. From the photo-analysis, the vehicle came off the dolly with a low roll rate, reaching the driver's side at 89 °/sec such that it slid on the driver side before generating the roll momentum to result in the average roll rate in the first roll of 285 °/sec. The average roll rate in the second roll was 335 °/sec. The average roll rate in the last roll was 100 °/sec.

The vehicle kinematics during the rollover were unusually severe involving, on the second roll, substantial lofting and pitch (the vehicle elevated about 2 feet (61 cm) into the air and pitched down about 10°). Interior video and photographs indicate that the roof matchboxed. [Matchboxing is when the roof shifts from side to side rather than collapsing on one side.] This happened because the HALO™ connected the two sides, and when the vehicle rolled, the sides shifted together laterally in the same direction due to the horizontal loading component. It distorted vertically in opposite directions (when the driver side was depressed the passenger side expanded). As a result, there was no significant possibility of loading the passengers that would result in an injury. The only foreseeable circumstance during this three roll event where an injury could occur is if an unbelted driver's head was at the A-pillar on the driver side in the second roll.

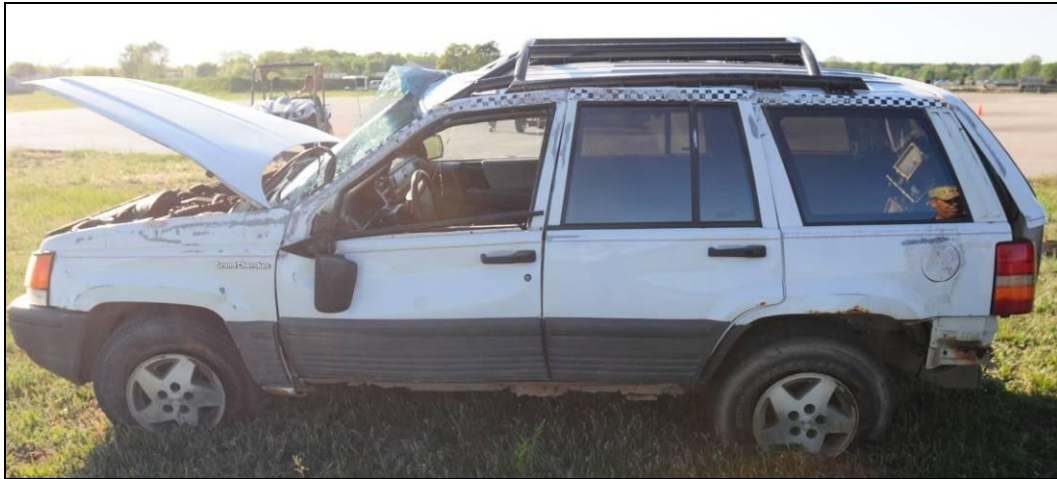
The vertical displacement and velocity on the driver's side at the mid A/B roof rail and B-pillar are unlikely to be injurious. Also, all glass remained intact, except the driver window, limiting ejection possibilities to unbelted occupants. Photographs taken immediately after the vehicle came to rest show a flat roof interior somewhat lower on the driver's side and higher on the passenger side. A photograph of the exterior is shown in Figure 11.

Figure 11. Prototype 4 HALO™ after a 3 roll dolly rollover test

Table 5 is a summary list of peak measured driver-side roof crush and roof crush speed on each roll at the middle of the roof rail between the A and B-pillars and directly at the B-pillar (where most head injury marks for restrained occupants are found). Also shown is the inferred medical probability of injury severity by the Abbreviated Injury Scale (AIS) according to the correlation algorithms proposed by Friedman et al (2009).

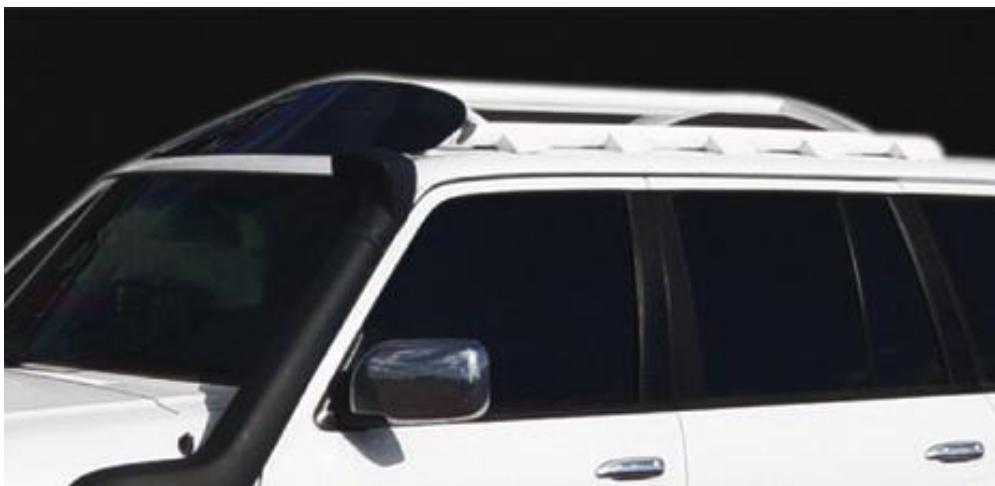
The final prototype was developed into the production HALO™ and was mounted on a 4WD vehicle for use in Australia as shown in Figure 12.

Figure 12. Final HALO™ mounted on 4WD for use in Australia

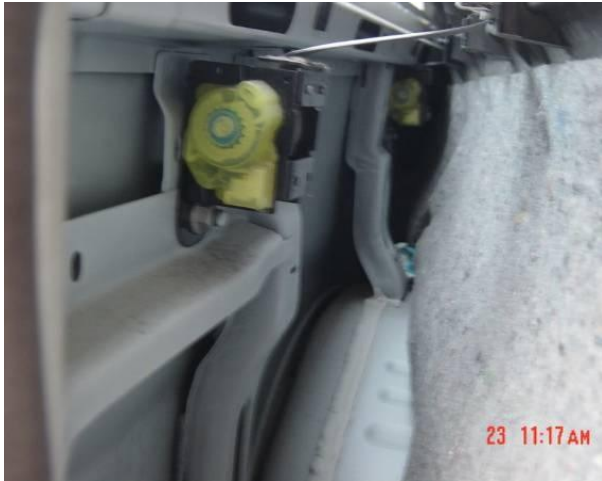
Once the SUV version of the HALO™ was completed, an interior retrofit strengthening system and external HALO™ was designed for a 12 to 15 passenger van, constructed, and installed. First, we performed a thorough examination of the production van structure. Weaknesses were identified. For example, there are no vertical load-bearing pillars between the B-pillars and the D-pillars and the distance between the load-bearing B-pillars and D-pillars is approximately 10 feet and excessive (Figure 13).

Figure 13. Non-structural pillars

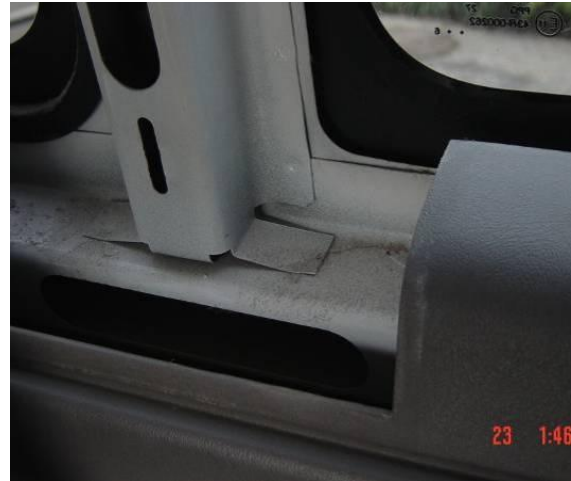
- On the driver's side, the vertical roof C-pillar is essentially a "false" non-structural pillar that provides only the minimum structure necessary to support the window sill (Figure 14).

Figure 14. Driver-side "false" pillars

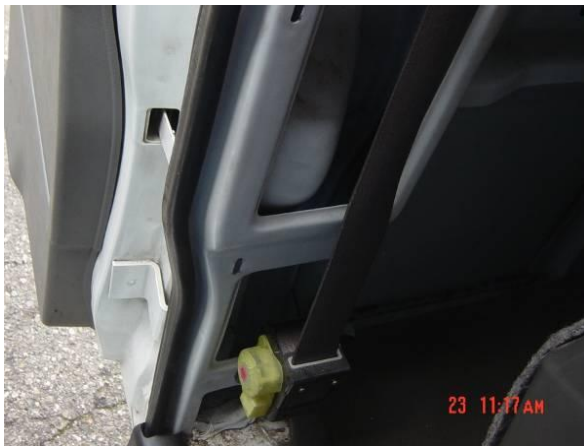
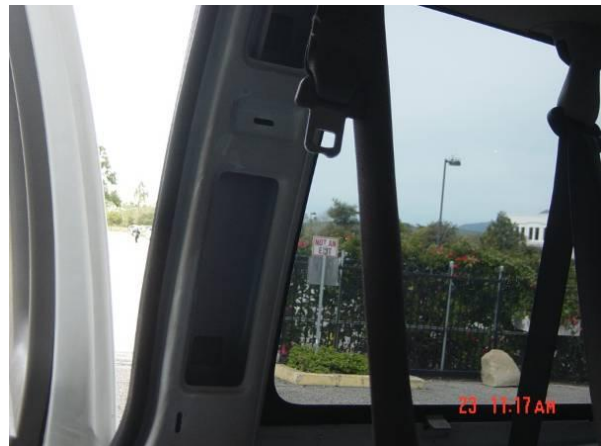
- On the passenger's side, the "C-pillar" has a relatively large overall profile, but is constructed of a single-layer 0.05-inch steel sheet and has open interior sections (Figures 15) that negate its strength, and necks down to a much smaller cross-section on its exterior and likely fails in buckling or local bending when subjected to the high stress concentrations in a rollover.

Figure 15. Passenger-side lower (left) and upper (right) C-pillar open sections

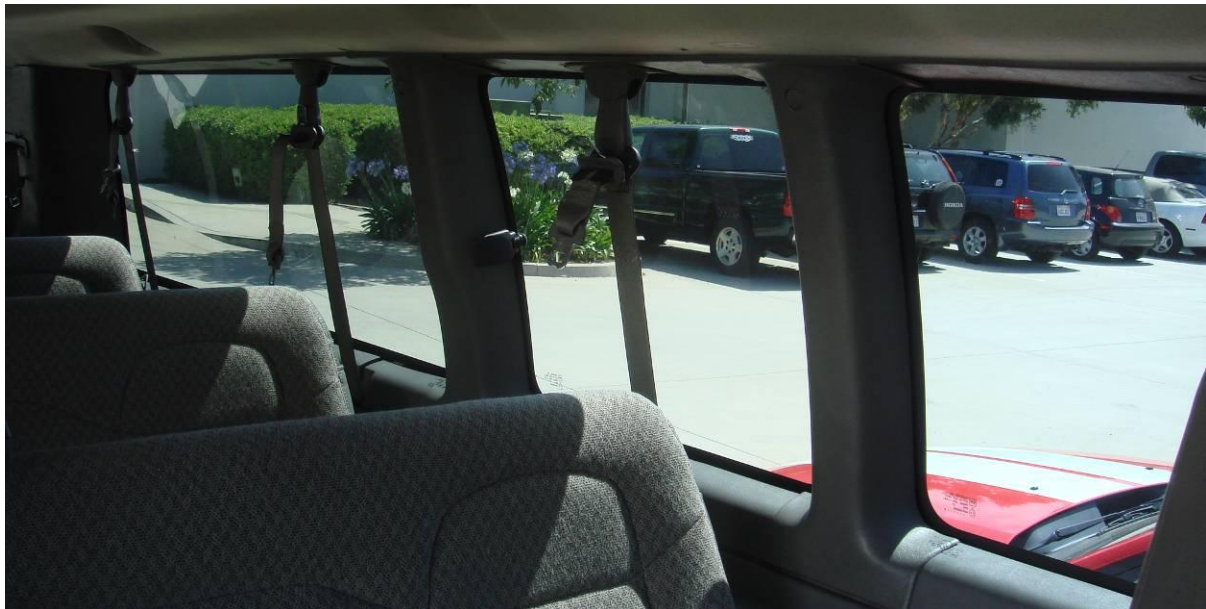
Figure 16 shows the production vehicle. Figure 17 shows the modifications for the proposed internal retrofit strengthening system.

Figure 16. Production passenger van

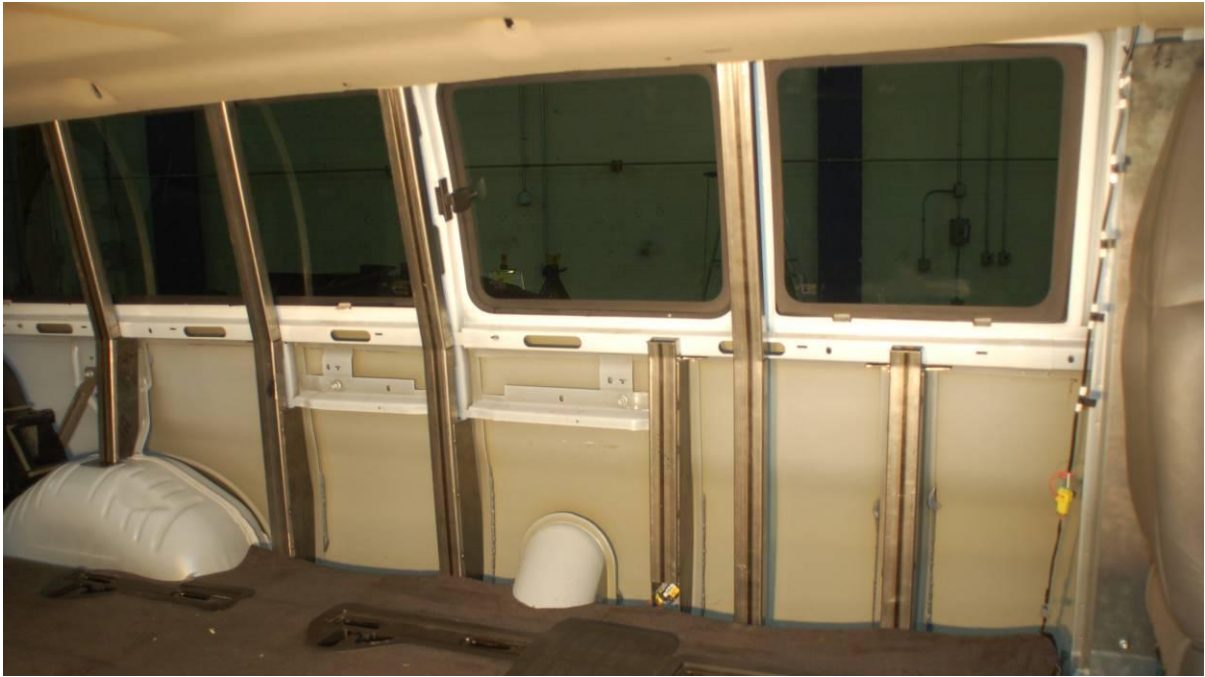
Figure 17. Passenger van internal retrofit strengthening system

- Driver-Side B-Pillar Reinforcement within the interior plastic
- Four additional Driver-Side Structural Pillars were
 - attached to the floor, roof rail, window sill, and
 - gloved over the existing “false” pillars and then riveted to the pillar with plates added to the floor in the region of each newly added pillar
- Two additional short pillars were added to the Driver-Side stemming from the floor to window sill in order to provide better lateral support to the region.

- Passenger-Side B-Pillar reinforcement within the interior plastic.
- Passenger-Side C-Pillar reinforcement within the interior plastic.
- Two additional Passenger-Side Structural Pillars were
 - attached to the floor, roof rail, window sill, and
 - gloved over the existing “false” pillars and then riveted to the pillar with plates added to the floor in the region of each newly added pillar

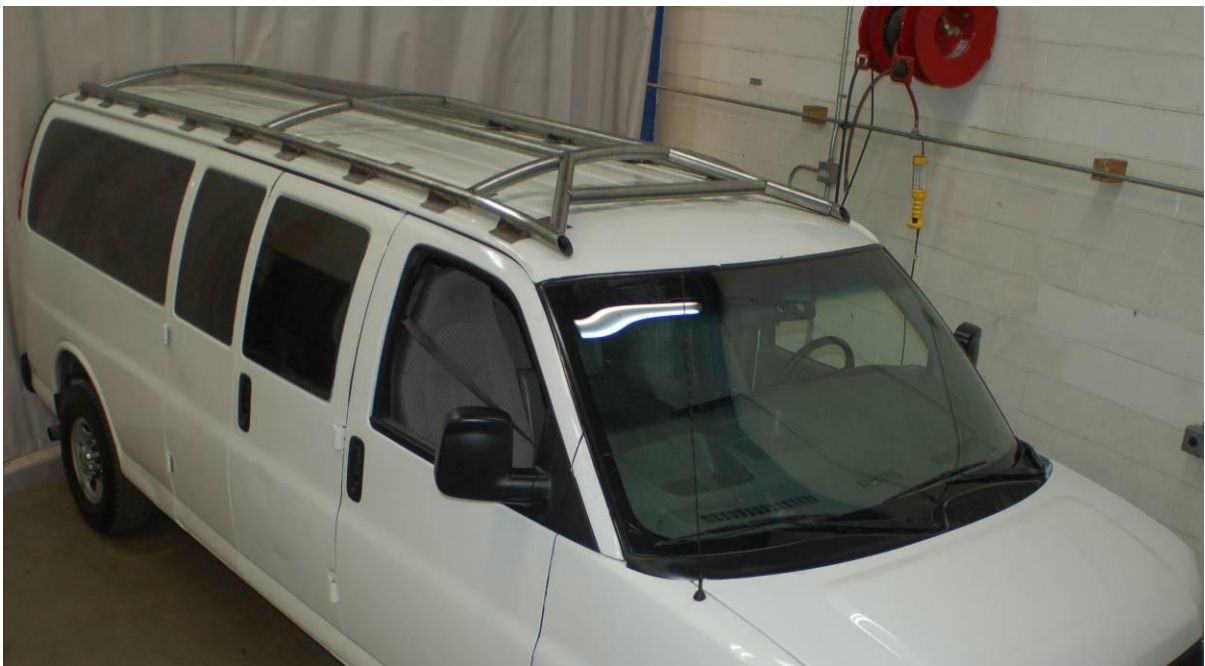
After finalizing the internal requirements for the retrofit, an external HALO™ was designed for the roof. Due to the length of this vehicle, the triple-hoop design shown in Figure 18 was developed for the van. With the proposed retrofit strengthening system, it is expected that the vehicle could withstand typical rollover roof loads.

Figure 18. 12 to 15 Passenger van with HALO™ rollover load distribution device.
