## PREDICTING AND VERIFYING DYNAMIC OCCUPANT PROTECTION

Paper Number 11-0090

The objective of this paper is to describe the developments that provide the basis for predicting new car occupant protection in real-world rollovers.

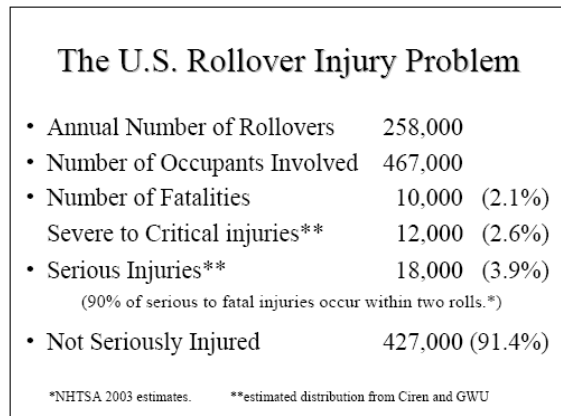
Rollover crash statistics are summarized in Figure 1. They indicate that 94% of people in rollovers are not seriously injured and that the remaining 6% are divided; about 2% each between fatalities, severe and serious injuries in 2-roll events.

Figure 1. Typical rollover statistics.

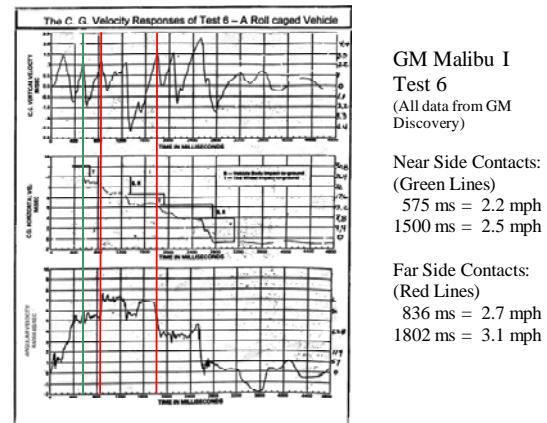
In the Malibu dolly rollover tests of strong-roofed vehicles at 32 mph, the roof impact speed was 21 mph with a 4-inch drop height and an average roll rate of about 6 rad/sec with 2 rolls. Figure 2 shows data from Malibu Series 1 Test 6.

Figure 2. GM Malibu I test no. 6.

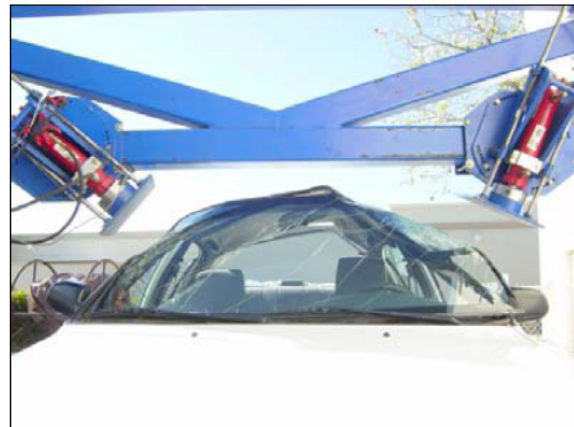
The M216 two-sided fixture applies forces to the roof on one side and then the other at force angles of 10° pitch and 25° and 40° roll, respectively. The M216 results indicate that most vehicles are about half as strong compared to the FMVSS 216 test results at 5° of pitch, as shown in Figures 3 and 4.

Figure 3. M216 two-sided static test machine.

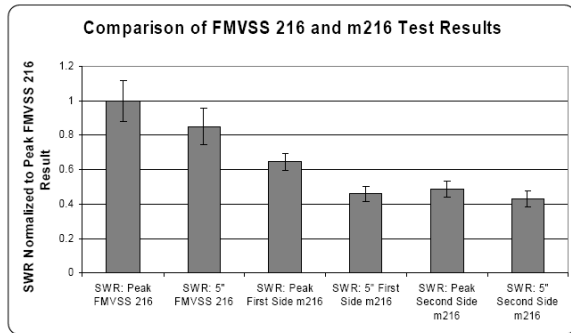
Figure 4. Two-sided NHTSB/M216 data.

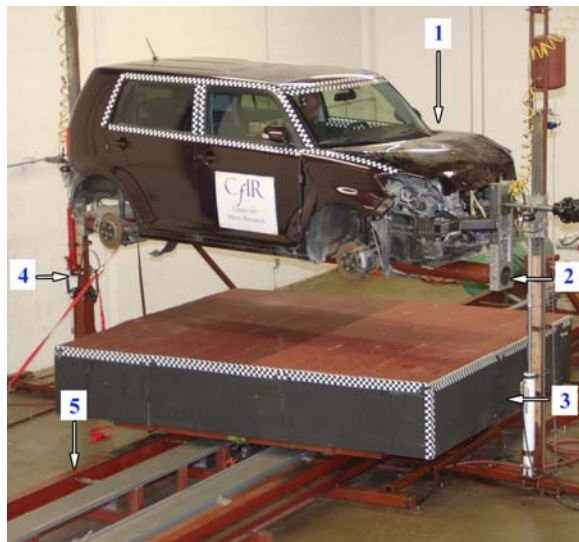
The JRS rollover fixture, shown in Figure 5, is a laboratory device capable of rolling full-size vehicles to 6,000 lbs at 300°/sec, dropping them 4 to 9 inches onto a 20 mph moving roadbed and measuring the roadbed forces and roof intrusion [8].

Figure 5. The JRS fixture key components: 1) vehicle, 2) cradle/spit mount, 3) moving roadbed, 4) support towers, 5) coupled pneumatic roadbed propulsion and roll drive.

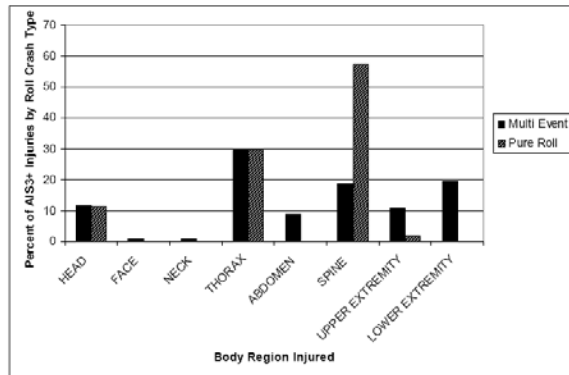
Two studies 25 years apart indicate that spinal distortions and fractures, primarily in the lower neck are typical rollover injury patterns. The 1983 Allen study of severe human neck injuries attributed 60% to flexion, 30% to extension and 10% to axial compression [9]. The 2009 Ridella study of CIREN cases indicates that a predominance of serious injuries involved the spine as shown in Figure 8 [10].

Figure 8. CIREN distribution of rollover injuries.

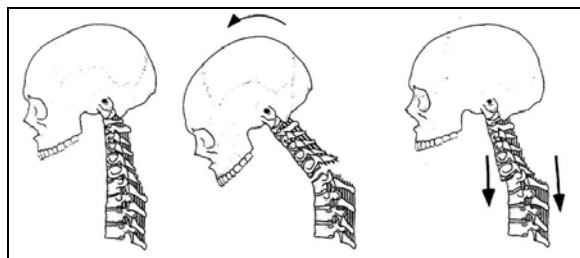
Figure 9 shows the mechanism of a common neck bending injury, a bilateral facet dislocation. It is initiated by significant flexion of the neck which dislocates the spine. It concludes with the neck contracting, pulling the spine forward and down locking the facets [11].

Figure 9. Hyperflexion neck injury mechanism from Pintar, et al.

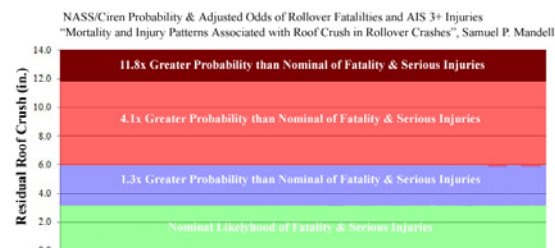
Figure 10 shows the 2009 Mandell studied the NASS/CIREN database and established a four level probability of injury risk as a function of vertical residual crush to 14 inches.

Figure 10. NASS/CIREN probability and adjusted odds.

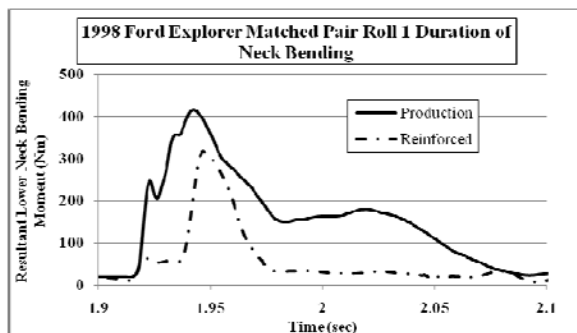
It is clear from the JRS test videos of the dummy head/neck motion that the roof of the production vehicles interact with the head of the soft neck dummy in a much more severe manner. The reinforced roofs provided much more protection by maintaining the occupant survival space. This is illustrated by superimposing the lower neck bending moment of an identical pair of production and reinforced Ford Explorers. The IBM is the respective areas under the bending time histories curves in Figure 11.

**Figure 11. 1998 Ford Explorer matched pair testing roll 1.**

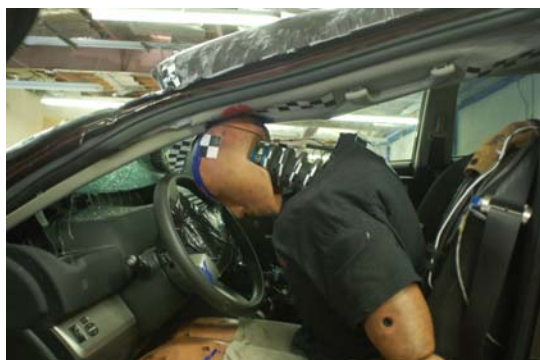
The “soft” low musculature modified Hybrid III dummy neck shown in Figure 12 was literally broken at the lower neck load cell mount as a result of 11 inches of roof crush in this SWR 6.8 vehicle.

**Figure 12. Soft neck of hybrid III dummy.**

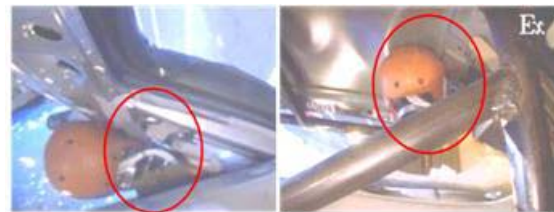
**tests** Published 15 ms video clips and neck injury measure data of production and reinforced 1998 Crown Victorias tested on the CRIS show identical results in roll-caged and production vehicles [16]. In the video dummy movement up to the point of initial roof contact is nearly identical. However, the videos and data to 140 ms tell a very different story. Figure 13 show the interior views. The production vehicle with the grossly bent neck is shown on the left. The deformation of the roof in the production vehicle applied a force to the head of the dummy and caused the neck to bend significantly. No neck bending was observed in the reinforced vehicle (right). Estimated roof crush is 2 inches for reinforced and more than 10 inches for the production vehicle.

**Figure 13. Production vehicle's neck severely bent after 40 ms (left) and the roll-caged vehicle's non-injurious neck bending (right).**

The peak lower neck bending moments measured in the production vehicles was 30 to 56% greater than in the reinforced vehicle. The duration of neck bending in the production vehicle was 150% greater than the reinforced vehicles. Dummies in the production vehicles were trapped 2 out of the 5 times in injurious positions that could limit breathing and inhibit safe evacuation [16].

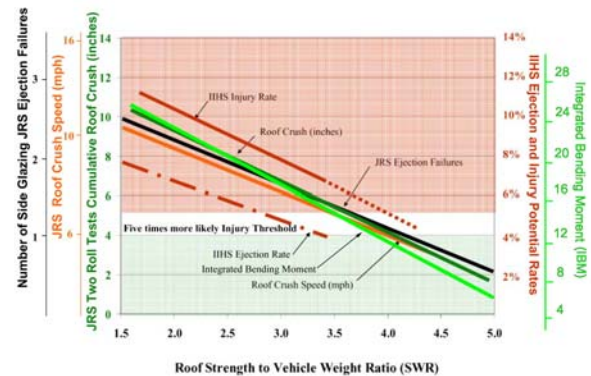
**SWR vs. cumulative residual roof crush** Figure 14 shows the generic injury measures with about the same slope as a function of SWR to 4 and injury risk to about 4 or 5%. The chart incorrectly projected the JRS test data to an SWR of 5, but subsequent tests of vehicles with SWR above 4 and to 6.8 correlate with a polynomial relationship primarily because one vehicle with an SWR of 6.8 had 10 inches of crush. In a companion paper 2011-0405 this set of data is

**Figure 14. Roll 2: cumulative residual crash and major radius.**

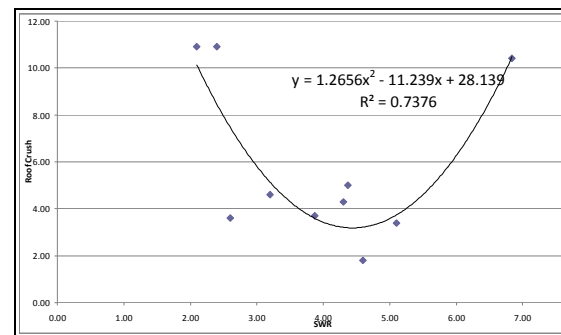
Other characteristics, particularly vehicle geometry and elasticity, have been identified to account for this non-linearity [18]. The current cumulative residual crush chart versus SWR is shown in Figure 15. This is still consistent with IIHS’ original statistical slopes of SUVs and small passenger cars to an SWR of 4 [19].

**Figure 15. SWR vs. current cumulative residual roof crush.**

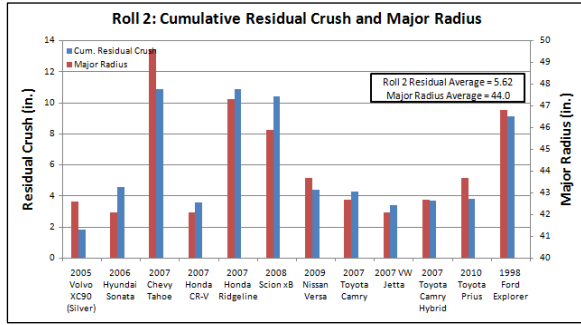
The major radius of a vehicle is the distance between the CG axis and the roof rail at the A-pillar. Figure 16 identifies the vehicles involved, their major radii and the cumulative residual crush at the A-pillar in roll 1 and roll 2.

Figure 16. Major radius and cumulative residual crush.

line is 0.659 meaning there is some correlation between the two. A further analysis shows Figure 24 only takes into consideration the magnitude of the distance between the CG and the A-pillar at 10° of pitch. The three vehicles that experience the most residual crush, the 2008 Scion xB, 2007 Chevy Tahoe, and the 2006 Honda Ridgeline, actually have their CG's behind the A-pillar at 10° of pitch. Their initial unloaded CG's are horizontally the farthest back of all the vehicle and even at 10° of pitch it is not enough to move their CG's forward of the A-pillar and pivot point. In reality these three vehicles are unlikely to roll with pitch because even at a forced pitch of 10° by the JRS, the CG, although it moves forward by a fair amount, is still behind the pivot point. From prior analyses we know that the 2008 Scion xB experiences a large residual crush due to its square profile and the 2007 Chevy Tahoe experiences large residual crush due to its weak roof structure with a SWR of 2.1 and because it has one of the largest major radiuses as shown previously in Figure 16 [20].

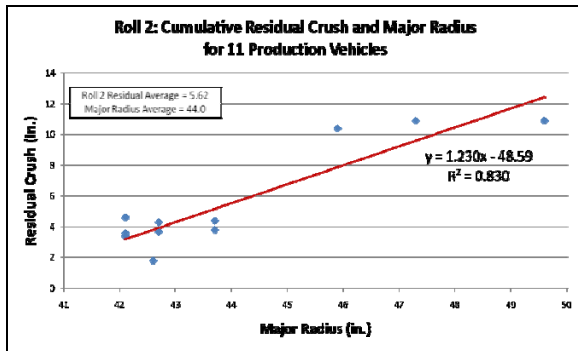
Figure 17 is a scatter plot of the Major radii for those vehicles and indicates a high correlation with the cumulative residual crush of roll 1 and 2. The relationship is particularly striking for the slope which indicates that each 1.2 inches of major radius affects the residual crush by 1 inch. This is an enormous effect easily doubling the magnitude of residual roof crush between SUVs and automobiles. Considering IIHS studies to reduce risk by 24% for each increment of SWR, reducing the major radius of SUVs from a typical 46 inches to that of automobiles, the XC-90 and CR-V of 42 inches reduces intrusion by 3.3 inches [19].

Figure 17. A scatter plot of the cumulative residual crush of roll 1 and roll 2 vs. major radius.

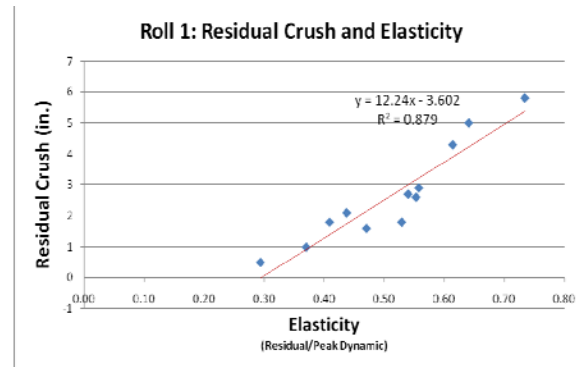
To interpret the data, vehicles with an elastic structure like the 70% Volvo XC-90 have a lesser effect on residual crush than vehicles like the 30% Scion xB which buckled and collapsed. Figure 18 shows that an elastic structure has a significant

Figure 18. Roll 1 residual crush and elasticity.

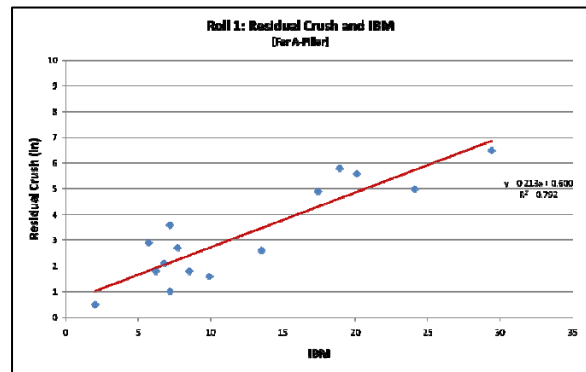
From an injury measure point of view the IBM correlates well with residual crush, with injury risk at 3.5 inches, with the 10% probability of AIS = 3+ IARV injury measure and seems insensitive to small variations of dummy head position. Three and a half (3.5) inches of residual crush corresponds to an IBM of 13.5 as shown in Figure 19.

Figure 19. Roll 1: Residual crush and IBM [far A-pillar].

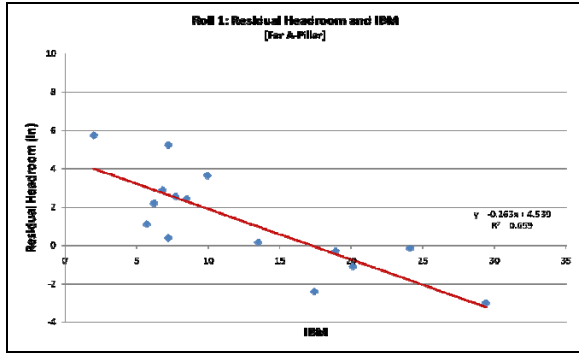
When considering dummy injury measures headroom is significant as shown in Figure 20.

Figure 20. Headroom vs. residual crush

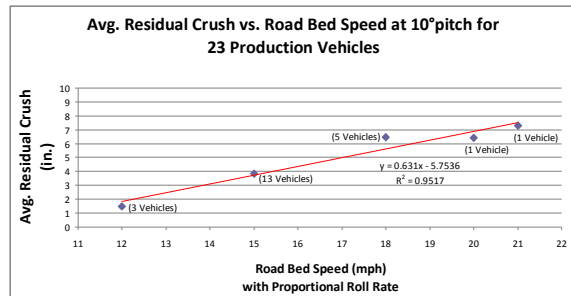
**Road speed and proportional roll rate** There is a high correlation between average residual crush and road speed with proportional roll rate as shown in Figure 21. The roll rate proportionality comes from the JRS I configuration where the road speed and roll rate are geared together. One test was performed with an alternate ratio resulting in a 15 mph and 303 deg/sec roll rate.

Figure 21. Average residual crush vs. road bed speed.

The point is that if 10° pitch accounts for 30% (the Jimmy's) and pitch and speed with proportional roll rate (the Hyundai's) accounts for 70%, then the speed and proportional roll rate accounts for 40% for a speed and proportional roll rate increase of 40% (from 15 to 21 mph) as shown in Figure 21.

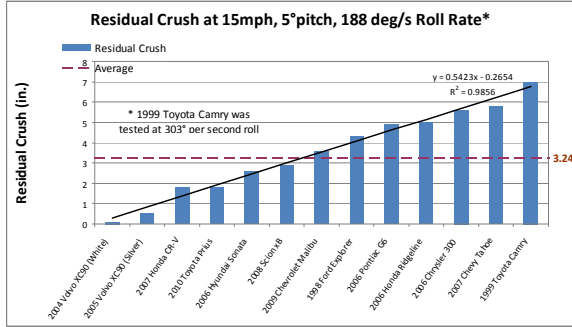
Still unresolved is whether that 40% increase is from increased road speed or roll rate. There is only one test at 15 mph, 5 deg pitch, 125 deg impact angle and 303° roll rate, a 1999 Camry, which could resolve that issue. The other tests were at 145 deg and 190 deg/sec. Previous 125 deg impact angle tests resulted in nearly equal near and far side road loads and intrusion. For the 1999 Camry the road loads and intrusion were very much greater on the far side. The 1999 Sonata and Camry are both estimated to have SWRs of about 2.8, yet the Camry residual crush of 7 inches shown in Figure 22 suggests that low impact angle and high roll rate result in a similar 7.3 inches of intrusion as the 21 mph and 280 deg/sec test. Finite element tests of a strengthened (SWR = 3.9) Explorer in a private communication indicated about the same dynamic intrusion in combinations of 40% increased speed and roll rate.

**Figure 22. Residual crush at 15mph, 5° pitch, 188 deg/s roll rate.**

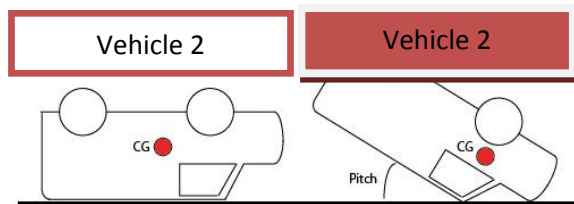
**Pitch and CG location** Pitch has been shown by JRS tests to be a highly sensitive parameter to roof crush. The difference in roof crush between 5 deg of pitch and 10 deg of pitch in JRS tests has typically been shown to be quite substantial. Most JRS tests are done in a 2 roll sequence in which the first roll is performed at 5 deg of pitch and the second roll is performed at 10 deg of pitch. The question is what vehicle parameter or characteristics would make a vehicle roll with a large degree of pitch. One explanation is that generally fully-loaded vehicles roll with little or no pitch. Taking this into consideration it would make sense that the location of the center of gravity (CG) of a vehicle relative to its A-pillars and pivot point is an important characteristic in determining the likelihood that a vehicle would roll with a pitch of 10° or greater. In theory, a vehicle whose CG is farther back from its A-pillars and behind its pivot point will likely roll flat on its roof. Thus the normal force of the road would be spread out over a larger surface area and result in less roof crush. A vehicle whose CG is closer to the A-pillars and forward of the pivot point will have a greater likelihood of rolling with a substantial pitch and thus result in greater roof crush. Both of these situations are illustrated below in Figure 23.

**Figure 23. Illustration of the two rollover situations.**

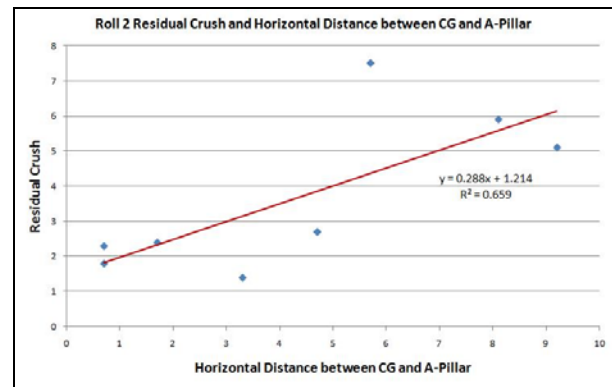
Given a situation in which the roof crush on the A-pillar of a vehicle is 6 inches and the roof crush on the B-pillar is 4 inches, the CG relative to the horizontal position of the virtual (undeformed) A-pillar was calculated and tabulated in column 5 of Table 3. Ten degrees of pitch was assumed given the 6 inches and 4 inches of roof crush on the A-pillar and B-pillar. In analyzing the data in column 5 from Table 3, the CG moves horizontally closer relative to the virtual A-pillar and in some cases moves forward of the pivot point causing the vehicle to want to pitch even further forward. Using the data for the horizontal distance between the CG relative to the A-Pillar at 10° of pitch and the residual crush for each respective vehicle in Roll 2 of the JRS test, a scatter plot was created and shown below in Figure 24.

**Figure 24. Roll 2 residual crush and horizontal distance between CG and A-pillar.**

The data in Figure 24 implies that the greater the distance between the CG and the A-pillar at 10° of pitch, the more residual roof crush the vehicle experienced. The R<sup>2</sup> value of the linear regression

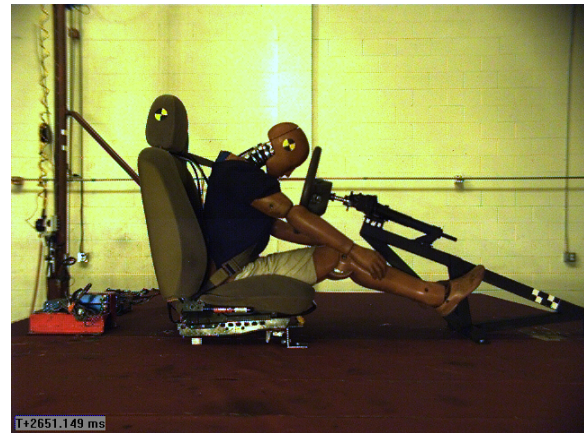
**Frontal impact protection** The reduction in musculature and orientation of the Hybrid III neck as developed for rollover testing appears to explain anomalies in frontal and side impact protection. For instance the IIHS reported an increase in fatalities with advanced airbags compared to the immediately previous designs [22]. An identical set-up for frontal impacts at typical airbag deployment ignition speeds of 15 mph is shown with the Hybrid III dummy with its original and reduced musculature neck in Figures 25 and 26, respectively. The flexibility of the reduced musculature puts the dummy's head in close proximity to the deploying airbag with serious injury consequences if the airbag fires and from striking the wheel hub if it doesn't.

Figure 25. Hybrid III dummy with original musculature neck.

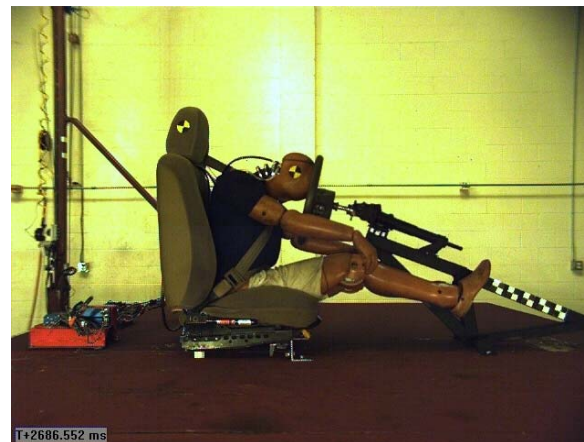
Figure 26. Hybrid III dummy with reduced musculature neck.
