PREDICTING AND VERIFYING DYNAMIC OCCUPANT PROTECTION

Center for Injury Research

Paper Number 11-0090

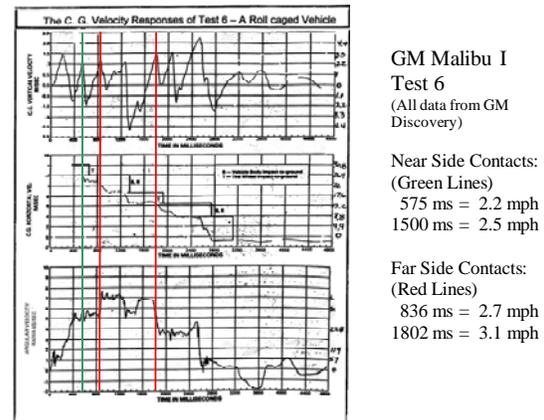
In the Malibu dolly rollover tests of strong-roofed vehicles at 32 mph, the roof impact speed was 21 mph with a 4-inch drop height and an average roll rate of about 6 rad/sec with 2 rolls. Figure 2 shows data from Malibu Series 1 Test 6.

Figure 2. GM Malibu I test no. 6.

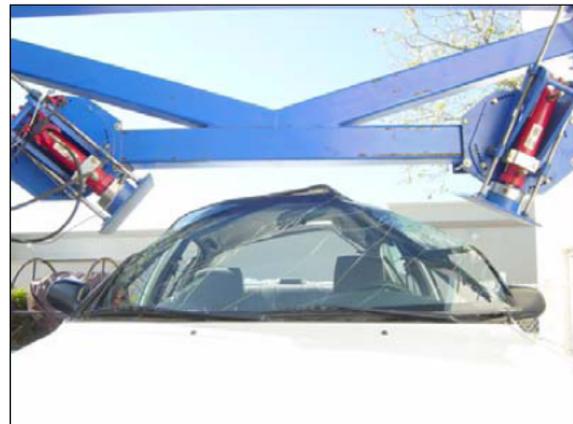
The M216 two-sided fixture applies forces to the roof on one side and then the other at force angles of 10° pitch and 25° and 40° roll, respectively. The M216 results indicate that most vehicles are about half as strong compared to the FMVSS 216 test results at 5° of pitch, as shown in Figures 3 and 4.

Figure 3. M216 two-sided static test machine.

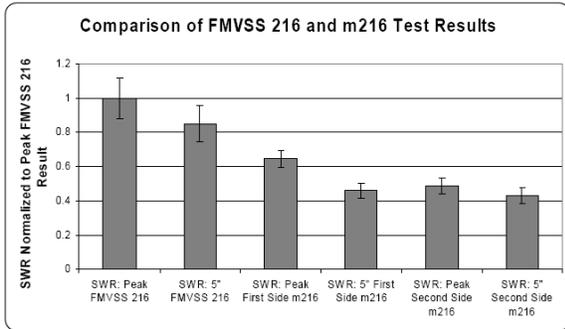
Figure 4. Two-sided NHSB/M216 data.

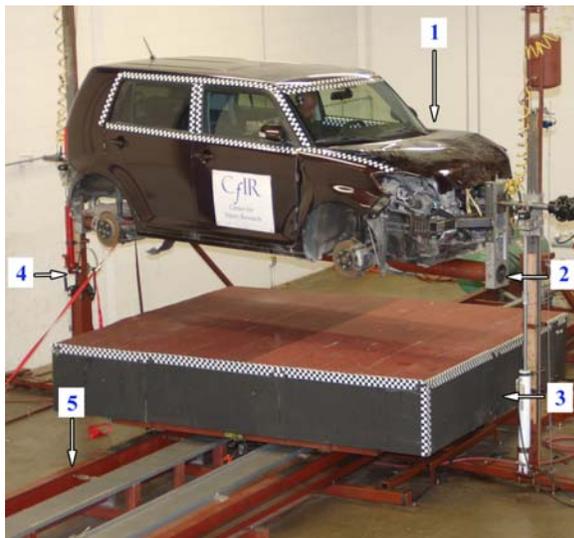
The JRS rollover fixture, shown in Figure 5, is a laboratory device capable of rolling full-size vehicles to 6,000 lbs at 300°/sec, dropping them 4 to 9 inches onto a 20 mph moving roadbed and measuring the roadbed forces and roof intrusion [8].

Figure 5. The JRS fixture key components: 1) vehicle, 2) cradle/spit mount, 3) moving roadbed, 4) support towers, 5) coupled pneumatic roadbed propulsion and roll drive.

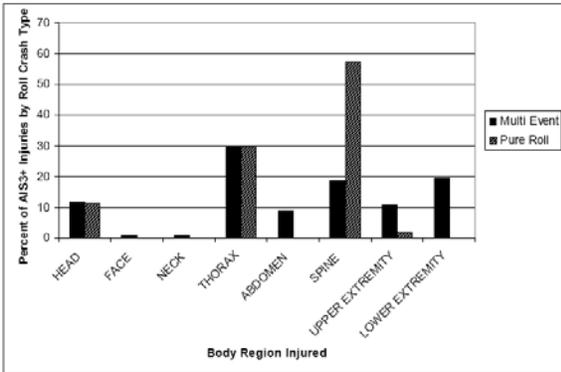
Two studies 25 years apart indicate that spinal distortions and fractures, primarily in the lower neck are typical rollover injury patterns. The 1983 Allen study of severe human neck injuries attributed 60% to flexion, 30% to extension and 10% to axial compression [9]. The 2009 Ridella study of CIREN cases indicates that a predominance of serious injuries involved the spine as shown in Figure 8 [10].

Figure 8. CIREN distribution of rollover injuries.

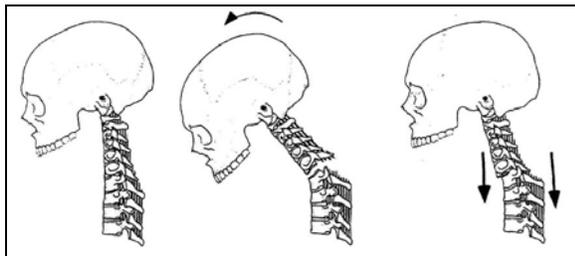
Figure 9 shows the mechanism of a common neck bending injury, a bilateral facet dislocation. It is initiated by significant flexion of the neck which dislocates the spine. It concludes with the neck contracting, pulling the spine forward and down locking the facets [11].

Figure 9. Hyperflexion neck injury mechanism from Pintar, et al.

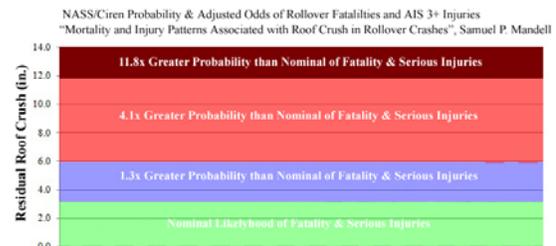
Figure 10 shows the 2009 Mandell studied the NASS/CIREN database and established a four level probability of injury risk as a function of vertical residual crush to 14 inches.

Figure 10. NASS/CIREN probability and adjusted odds.

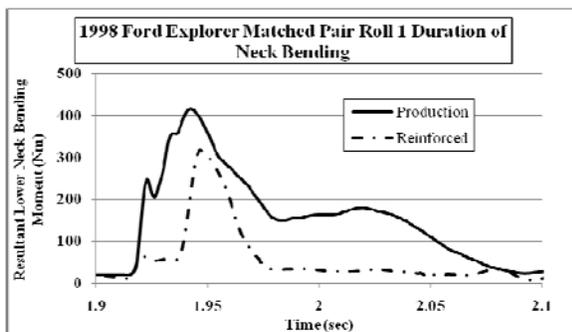
It is clear from the JRS test videos of the dummy head/neck motion that the roof of the production vehicles interact with the head of the soft neck dummy in a much more severe manner. The reinforced roofs provided much more protection by maintaining the occupant survival space. This is illustrated by superimposing the lower neck bending moment of an identical pair of production and reinforced Ford Explorers. The IBM is the respective areas under the bending time histories curves in Figure 11.

Figure 11. 1998 Ford Explorer matched pair testing roll 1.

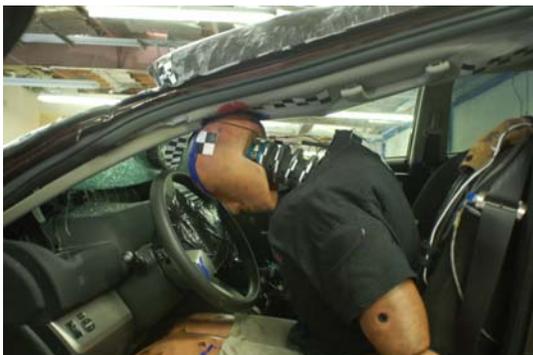
The “soft” low musculature modified Hybrid III dummy neck shown in Figure 12 was literally broken at the lower neck load cell mount as a result of 11 inches of roof crush in this SWR 6.8 vehicle.

Figure 12. Soft neck of hybrid III dummy.

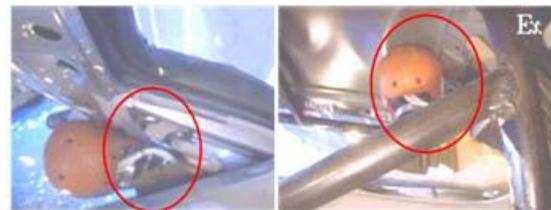
tests Published 15 ms video clips and neck injury measure data of production and reinforced 1998 Crown Victorias tested on the CRIS show identical results in roll-caged and production vehicles [16]. In the video dummy movement up to the point of initial roof contact is nearly identical. However, the videos and data to 140 ms tell a very different story. Figure 13 show the interior views. The production vehicle with the grossly bent neck is shown on the left. The deformation of the roof in the production vehicle applied a force to the head of the dummy and caused the neck to bend significantly. No neck bending was observed in the reinforced vehicle (right). Estimated roof crush is 2 inches for reinforced and more than 10 inches for the production vehicle.

Figure 13. Production vehicle's neck severely bent after 40 ms (left) and the roll-caged vehicle's non-injurious neck bending (right).

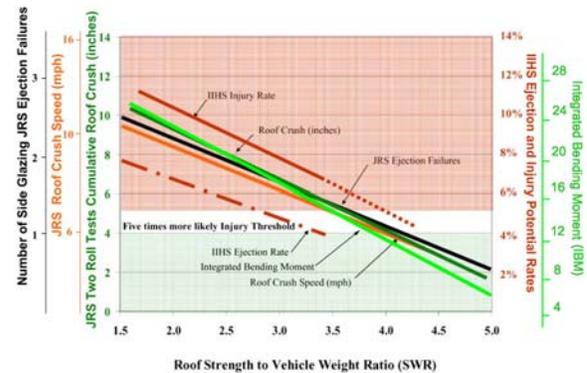
SWR vs. cumulative residual roof crush Figure 14 shows the generic injury measures with about the same slope as a function of SWR to 4 and injury risk to about 4 or 5%. The chart incorrectly projected the JRS test data to an SWR of 5, but subsequent tests of vehicles with SWR above 4 and to 6.8 correlate with a polynomial relationship primarily because one vehicle with an SWR of 6.8 had 10 inches of crush. In a companion paper 2011-0405 this set of data is

Figure 14. Roll 2: cumulative residual crash and major radius.

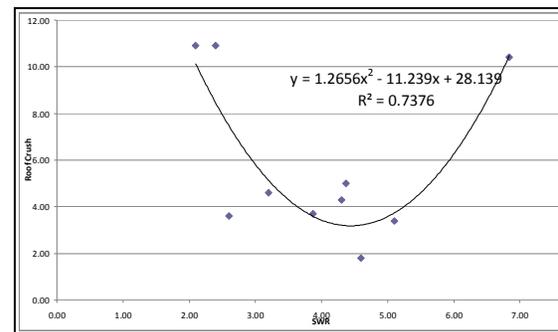
Other characteristics, particularly vehicle geometry and elasticity, have been identified to account for this non-linearity [18]. The current cumulative residual crush chart versus SWR is shown in Figure 15. This is still consistent with IIHS' original statistical slopes of SUVs and small passenger cars to an SWR of 4 [19].

Figure 15. SWR vs. current cumulative residual roof crush.

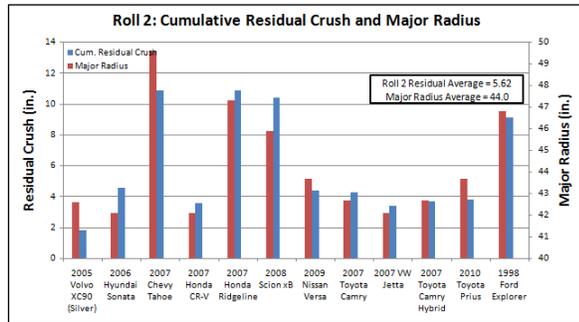
The major radius of a vehicle is the distance between the CG axis and the roof rail at the A-pillar. Figure 16 identifies the vehicles involved, their major radii and the cumulative residual crush at the A-pillar in roll 1 and roll 2.

Figure 16. Major radius and cumulative residual crush.

line is 0.659 meaning there is some correlation between the two. A further analysis shows Figure 24 only takes into consideration the magnitude of the distance between the CG and the A-pillar at 10° of pitch. The three vehicles that experience the most residual crush, the 2008 Scion xB, 2007 Chevy Tahoe, and the 2006 Honda Ridgeline, actually have their CG's behind the A-pillar at 10° of pitch. Their initial unloaded CG's are horizontally the farthest back of all the vehicle and even at 10° of pitch it is not enough to move their CG's forward of the A-pillar and pivot point. In reality these three vehicles are unlikely to roll with pitch because even at a forced pitch of 10° by the JRS, the CG, although it moves forward by a fair amount, is still behind the pivot point. From prior analyses we know that the 2008 Scion xB experiences a large residual crush due to its square profile and the 2007 Chevy Tahoe experiences large residual crush due to its weak roof structure with a SWR of 2.1 and because it has one of the largest major radiuses as shown previously in Figure 16 [20].

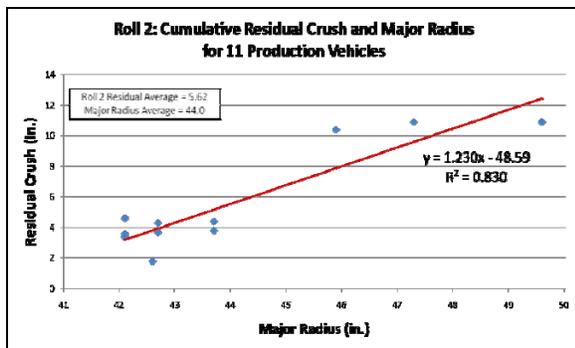
Figure 17 is a scatter plot of the Major radii for those vehicles and indicates a high correlation with the cumulative residual crush of roll 1 and 2. The relationship is particularly striking for the slope which indicates that each 1.2 inches of major radius affects the residual crush by 1 inch. This is an enormous effect easily doubling the magnitude of residual roof crush between SUVs and automobiles. Considering IIHS studies to reduce risk by 24% for each increment of SWR, reducing the major radius of SUVs from a typical 46 inches to that of automobiles, the XC-90 and CR-V of 42 inches reduces intrusion by 3.3 inches [19].

Figure 17. A scatter plot of the cumulative residual crush of roll 1 and roll 2 vs. major radius.

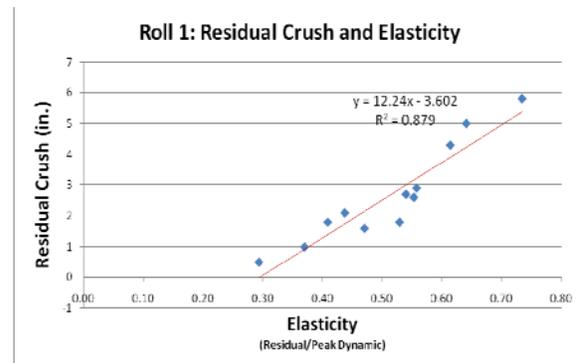
To interpret the data, vehicles with an elastic structure like the 70% Volvo XC-90 have a lesser effect on residual crush than vehicles like the 30% Scion xB which buckled and collapsed. Figure 18 shows that an elastic structure has a significant

correlation and slope with residual crush. The weighting compared to SWR and major radius is as yet unknown.

Figure 18. Roll 1 residual crush and elasticity.

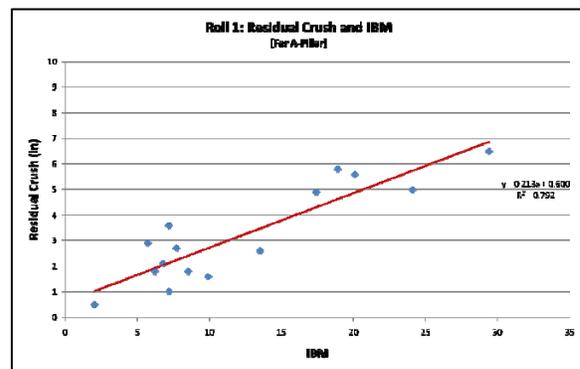
From an injury measure point of view the IBM correlates well with residual crush, with injury risk at 3.5 inches, with the 10% probability of AIS = 3+ IARV injury measure and seems insensitive to small variations of dummy head position. Three and a half (3.5) inches of residual crush corresponds to an IBM of 13.5 as shown in Figure 19.

Figure 19. Roll 1: Residual crush and IBM [far A-pillar].

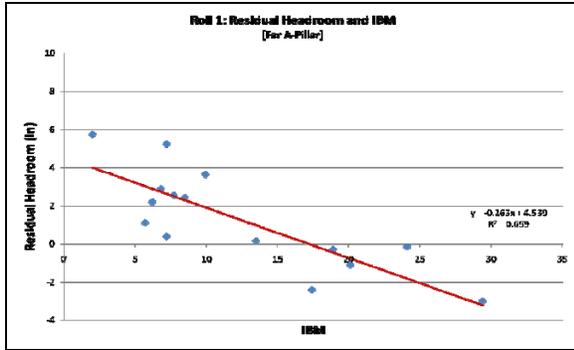
When considering dummy injury measures headroom is significant as shown in Figure 20.

Figure 20. Headroom vs. residual crush

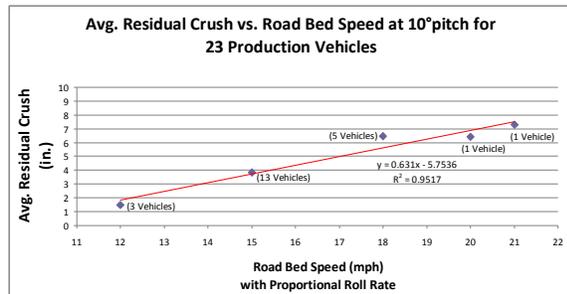
Road speed and proportional roll rate There is a high correlation between average residual crush and road speed with proportional roll rate as shown in Figure 21. The roll rate proportionality comes from the JRS I configuration where the road speed and roll rate are geared together. One test was performed with an alternate ratio resulting in a 15 mph and 303 deg/sec roll rate.

Figure 21. Average residual crush vs. road bed speed.

The point is that if 10° pitch accounts for 30% (the Jimmy's) and pitch and speed with proportional roll rate (the Hyundai's) accounts for 70%, then the speed and proportional roll rate accounts for 40% for a speed and proportional roll rate increase of 40% (from 15 to 21 mph) as shown in Figure 21.

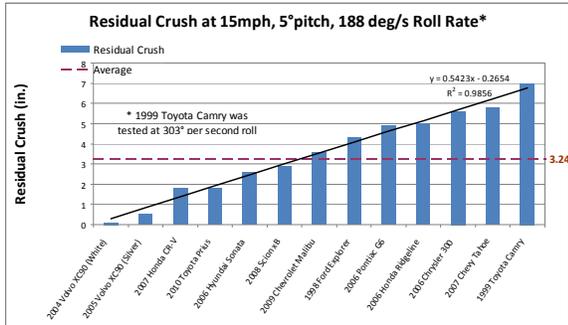
Still unresolved is whether that 40% increase is from increased road speed or roll rate. There is only one test at 15 mph, 5 deg pitch, 125 deg impact angle and 303° roll rate, a 1999 Camry, which could resolve that issue. The other tests were at 145 deg and 190 deg/sec. Previous 125 deg impact angle tests resulted in nearly equal near and far side road loads and intrusion. For the 1999 Camry the road loads and intrusion were very much greater on the far side. The 1999 Sonata and Camry are both estimated to have SWRs of about 2.8, yet the Camry residual crush of 7 inches shown in Figure 22 suggests that low impact angle and high roll rate result in a similar 7.3 inches of intrusion as the 21 mph and 280 deg/sec test. Finite element tests of a strengthened (SWR = 3.9) Explorer in a private communication indicated about the same dynamic intrusion in combinations of 40% increased speed and roll rate.

Figure 22. Residual crush at 15mph, 5° pitch, 188 deg/s roll rate.

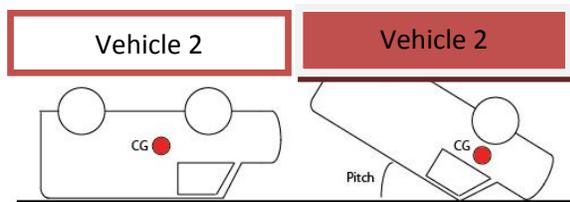
Pitch and CG location Pitch has been shown by JRS tests to be a highly sensitive parameter to roof crush. The difference in roof crush between 5 deg of pitch and 10 deg of pitch in JRS tests has typically been shown to be quite substantial. Most JRS tests are done in a 2 roll sequence in which the first roll is performed at 5 deg of pitch and the second roll is performed at 10 deg of pitch. The question is what vehicle parameter or characteristics would make a vehicle roll with a large degree of pitch. One explanation is that generally fully-loaded vehicles roll with little or no pitch. Taking this into consideration it would make sense that the location of the center of gravity (CG) of a vehicle relative to its A-pillars and pivot point is an important characteristic in determining the likelihood that a vehicle would roll with a pitch of 10° or greater. In theory, a vehicle whose CG is farther back from its A-pillars and behind its pivot point will likely roll flat on its roof. Thus the normal force of the road would be spread out over a larger surface area and result in less roof crush. A vehicle whose CG is closer to the A-pillars and forward of the pivot point will have a greater likelihood of rolling with a substantial pitch and thus result in greater roof crush. Both of these situations are illustrated below in Figure 23.

Figure 23. Illustration of the two rollover situations.

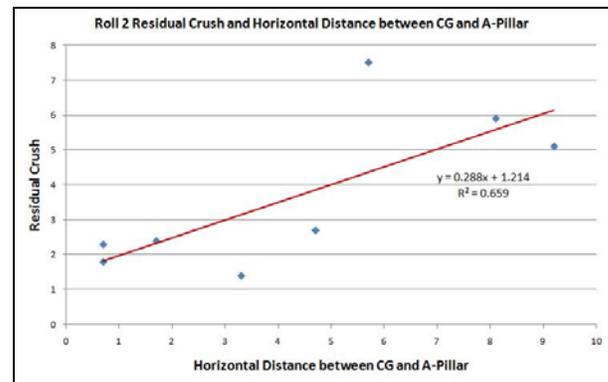
Given a situation in which the roof crush on the A-pillar of a vehicle is 6 inches and the roof crush on the B-pillar is 4 inches, the CG relative to the horizontal position of the virtual (undeformed) A-pillar was calculated and tabulated in column 5 of Table 3. Ten degrees of pitch was assumed given the 6 inches and 4 inches of roof crush on the A-pillar and B-pillar. In analyzing the data in column 5 from Table 3, the CG moves horizontally closer relative to the virtual A-pillar and in some cases moves forward of the pivot point causing the vehicle to want to pitch even further forward. Using the data for the horizontal distance between the CG relative to the A-Pillar at 10° of pitch and the residual crush for each respective vehicle in Roll 2 of the JRS test, a scatter plot was created and shown below in Figure 24.

Figure 24. Roll 2 residual crush and horizontal distance between CG and A-pillar.

The data in Figure 24 implies that the greater the distance between the CG and the A-pillar at 10° of pitch, the more residual roof crush the vehicle experienced. The R² value of the linear regression

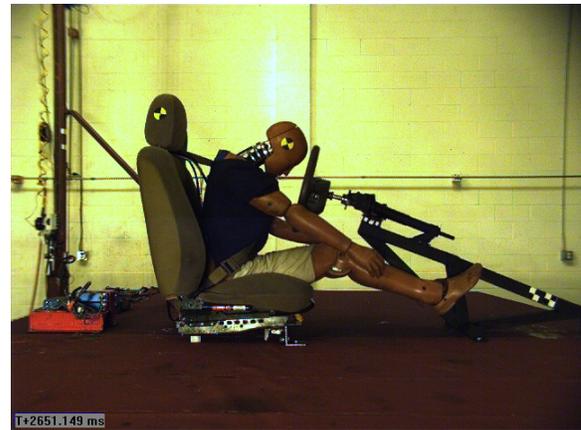
Frontal impact protection The reduction in musculature and orientation of the Hybrid III neck as developed for rollover testing appears to explain anomalies in frontal and side impact protection. For instance the IIHS reported an increase in fatalities with advanced airbags compared to the immediately previous designs [22]. An identical set-up for frontal impacts at typical airbag deployment ignition speeds of 15 mph is shown with the Hybrid III dummy with its original and reduced musculature neck in Figures 25 and 26, respectively. The flexibility of the reduced musculature puts the dummy's head in close proximity to the deploying airbag with serious injury consequences if the airbag fires and from striking the wheel hub if it doesn't.

Figure 25. Hybrid III dummy with original musculature neck.

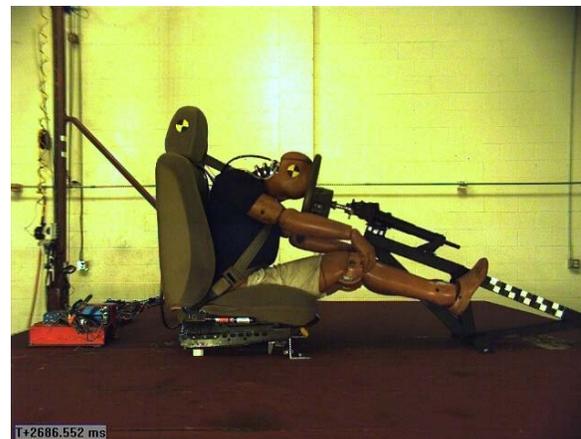
Figure 26. Hybrid III dummy with reduced musculature neck.
